## **30, 34-40 and 82 Campbell Street St Peters**

Catalogue of Historic Building Fabric

Prepared for CPB Dragados Samsung Joint Venture

November 2016

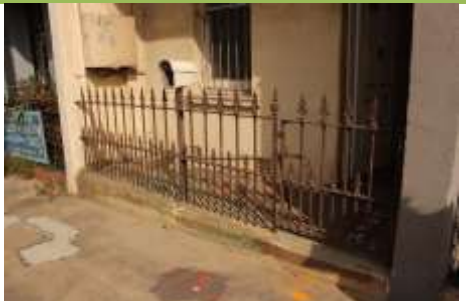
Ref. #	Feature	Qty	Notes	Hazardous Materials Present	Thumbnail
1	Wrought iron boundary fence	1	Only dwelling in terrace group with a gate.	Lead (pb) paint

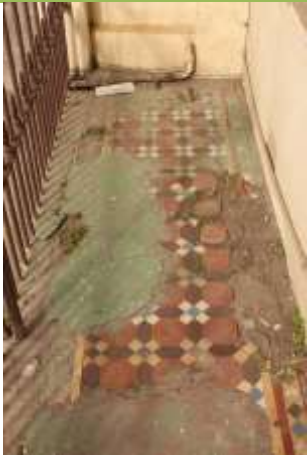
3	Verandah - wrought iron lacework	0			
4	Verandah – wrought iron fence	0			
5	Tessellated tiles	1	Poor condition

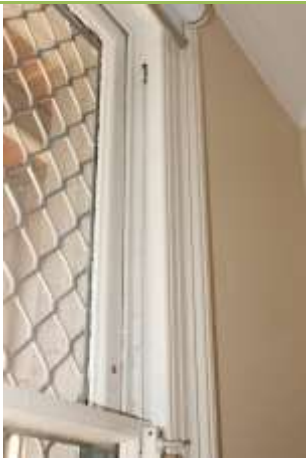
Ref. #	Feature	Qty	Notes	Hazardous Materials Present	Thumbnail
13	Window hardware - locks	8	One lock broken		
14	Window hardware – sash & pulley	8	Two sashes broken

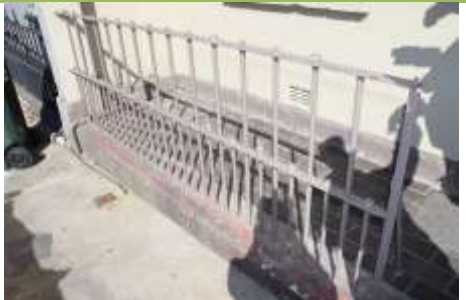
Ref. #	Feature	Qty	Notes	Hazardous Materials Present	Thumbnail
1	Wrought iron boundary fence	1	Poor condition. Incomplete, missing gate	Lead (Pb) paint

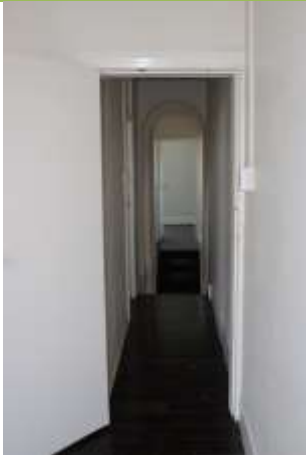
15	Window hardware – finger hooks	8			
16	Door joinery – timber frame	10		Lead (Pb) paint on all 10 frames

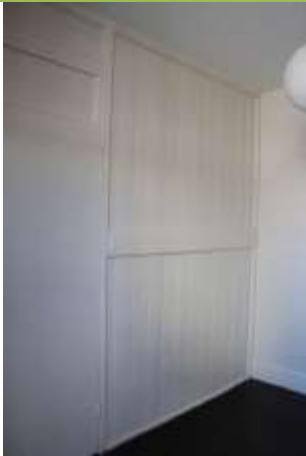
Ref. #	Feature	Qty	Notes	Hazardous Materials Present	Thumbnail
			timber boards have been replaced.		
27	Wall – beaded cladding	3		Lead (Pb) paint

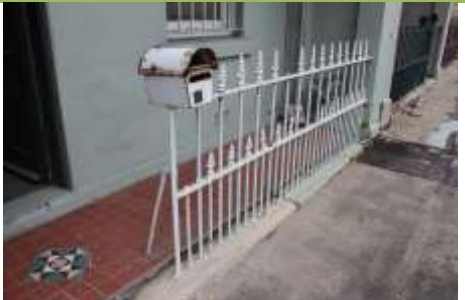
Ref. #	Feature	Qty	Notes	Hazardous Material Present	Thumbnail
1	Wrought iron boundary fence	1	Incomplete, missing some detailing and gate	Lead (Pb) paint

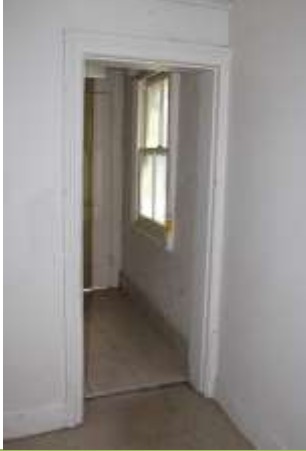
16	Door joinery – timber frame	10	Lead (Pb) paint on southern elevation door frame (rear) and western elevation door frame (exit from kitchen to side lane).

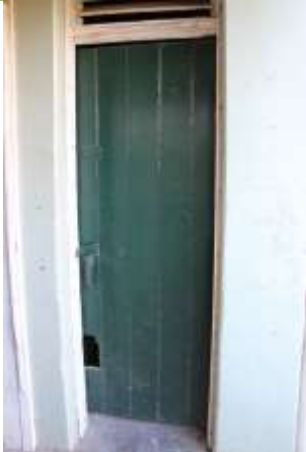
19	Door joinery – timber board & brace  <i>Note: this concerns the door only. The timber louvre vent above the bathroom door is of poor quality and low significance.</i>	1	Modified and in poor condition.

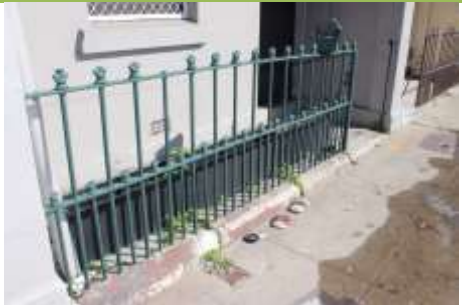
Ref. #	Feature	Qty	Notes	Hazardous Materials Present	Thumbnail
1	Wrought iron boundary fence	1	Incomplete, missing detailing and gate

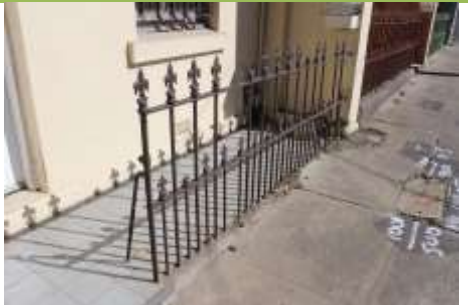
Ref. #	Feature	Qty	Notes	Hazardous Materials Present	Thumbnail
1	Wrought iron boundary fence	1	Incomplete, missing detailing and gate

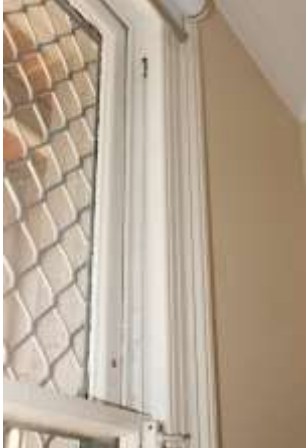
14	Window hardware – sash & pulley	8	One broken sash

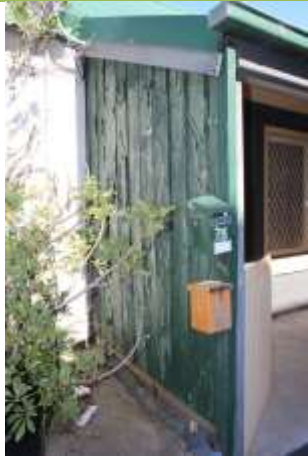
Ref. #	Feature	Qty	Notes	Hazardous Materials Present	Thumbnail
8	Timber cladding	1	During demolition, please check the exterior side of the verandah enclosure for original timber panels like those found at 80 Campbell Street

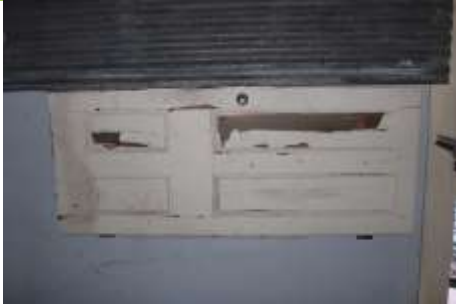
18	Door joinery – panel timber door	1	Poor condition.

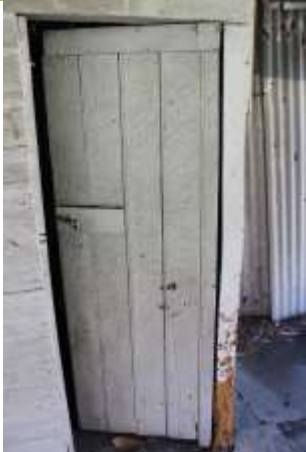
19	Door joinery – timber French door	0			
20	Door joinery – timber board & brace	1	Poor condition.

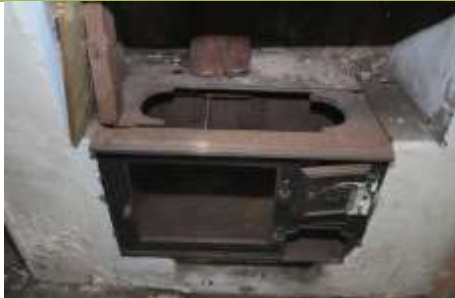
Ref. #	Feature	Qty	Notes	Hazardous Materials Present	Thumbnail
36	Stove	1	Poor condition and incomplete
