Pre-Construction Road Condition Report for WestConnex M5N

Project No: PSS17131

PSS17131-V2
June 2017

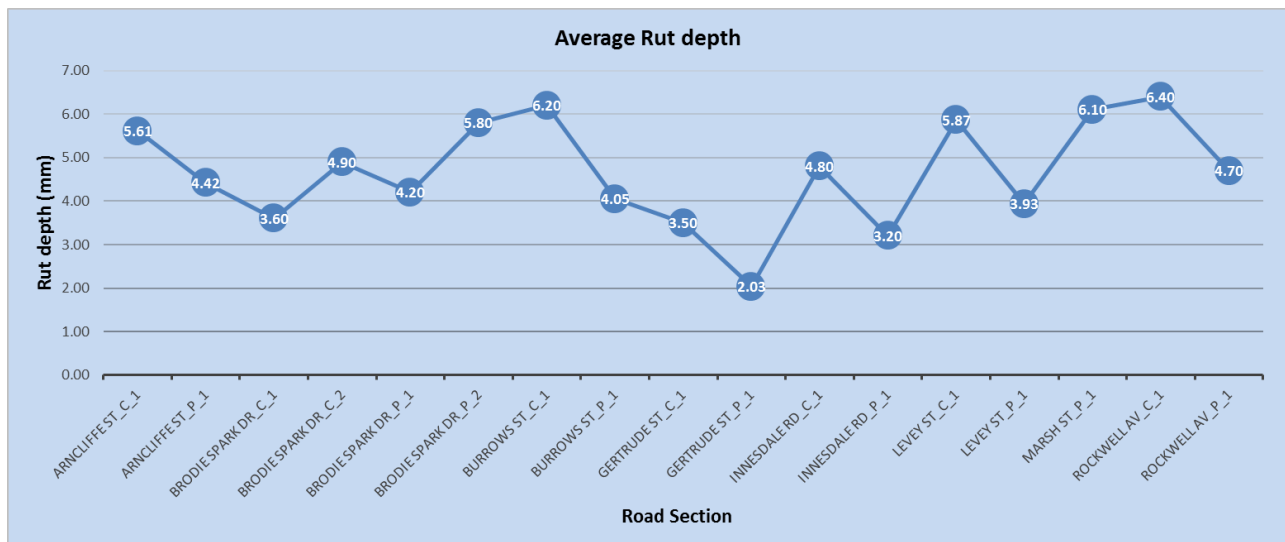
Figure 2.1: Average condition Rut depth Bayside Council

Figure 2.1 presents the average rut depth of each road section and the majority of the sections present rut depth of around 5mm, mostly in ‘good’ condition.

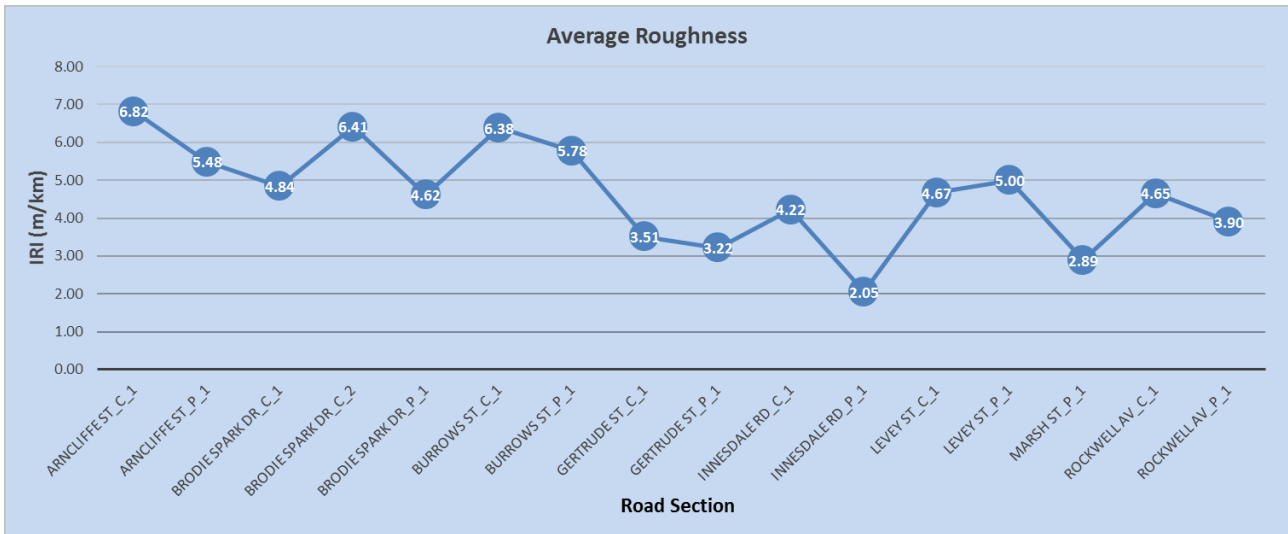
Figure 2.2: Average condition-Roughness-Bayside Council

Figure 2.2 shows the average roughness condition of each surveyed section. Most sections present roughness value of more than 4.2 IRI, which is considered ‘Poor’ according to the assumed level of service definitions (Section 1.3).

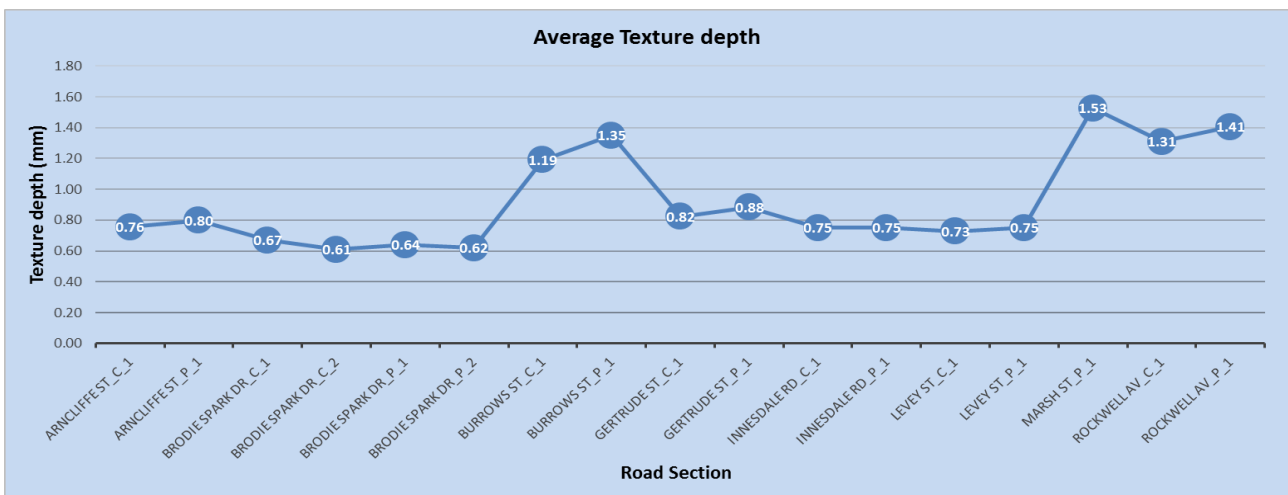
Figure 2.3: Average condition-Texture depth-Bayside Council

As indicated in Figure 2.3 all of the road sections have texture depth of 0.6 mm or more, which is considered 'Fair'/ "Good" condition for texture depth.

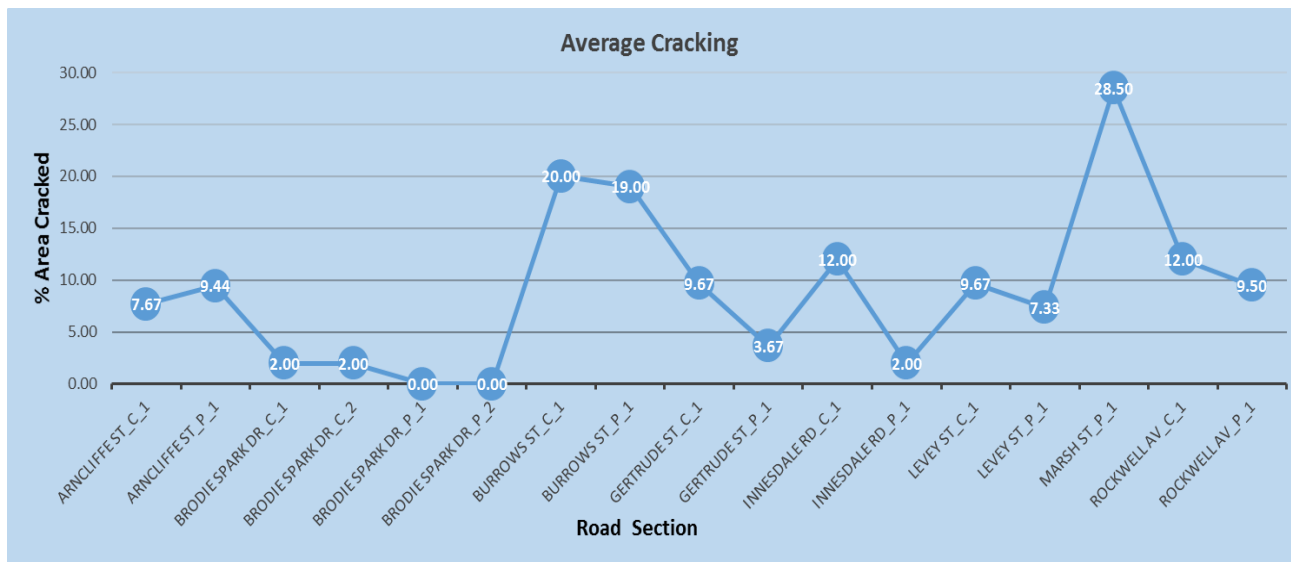
Figure 2.4: Average condition-Cracking-Bayside Council

Majority of the road sections of Bayside Council have less than 10% of area cracked and it is considered as ‘Good’.
