164 Parramatta Road, Annandale (former Bank of NSW)

Salvage Strategy and Sympathetic Re-use Report

Report to Lendlease Samsung
Bouygues Joint Venture

15 November 2018

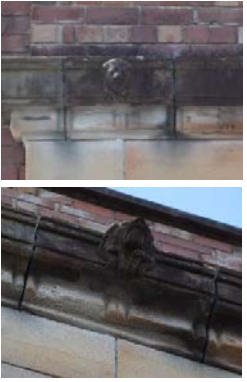
<p>Four off carved sandstone units spaced at intervals along cornice.</p> <p>More significant sanding and fretting to underside of these units.</p> <p>Some delamination cracking and spalling, particularly to underside.</p> <p>Extensive black biological staining to all visible surfaces.</p> <p>Further 'hands-on' inspection required to confirm extent of deterioration.</p> <p>Approx. dimensions: 500mmL x 420mmH x ??T</p>	<p>Some significance.</p> <p>Some salvage value (moderate).</p>	<p>All four gargoyle blocks could be considered for potential reuse on site</p>
Beam cladding

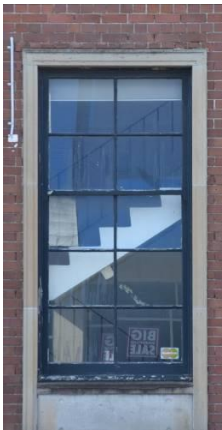
<p>Painted timber; paint in poor condition, peeling, missing in places; lead-based paint may be present.</p> <p>Timber weathered where exposed.</p> <p>Glazing putty cracked, missing in places; may contain asbestos.</p>	<p>No particular significance.</p> <p>Some salvage value (moderate).</p>	
L1 double hung sash / frames

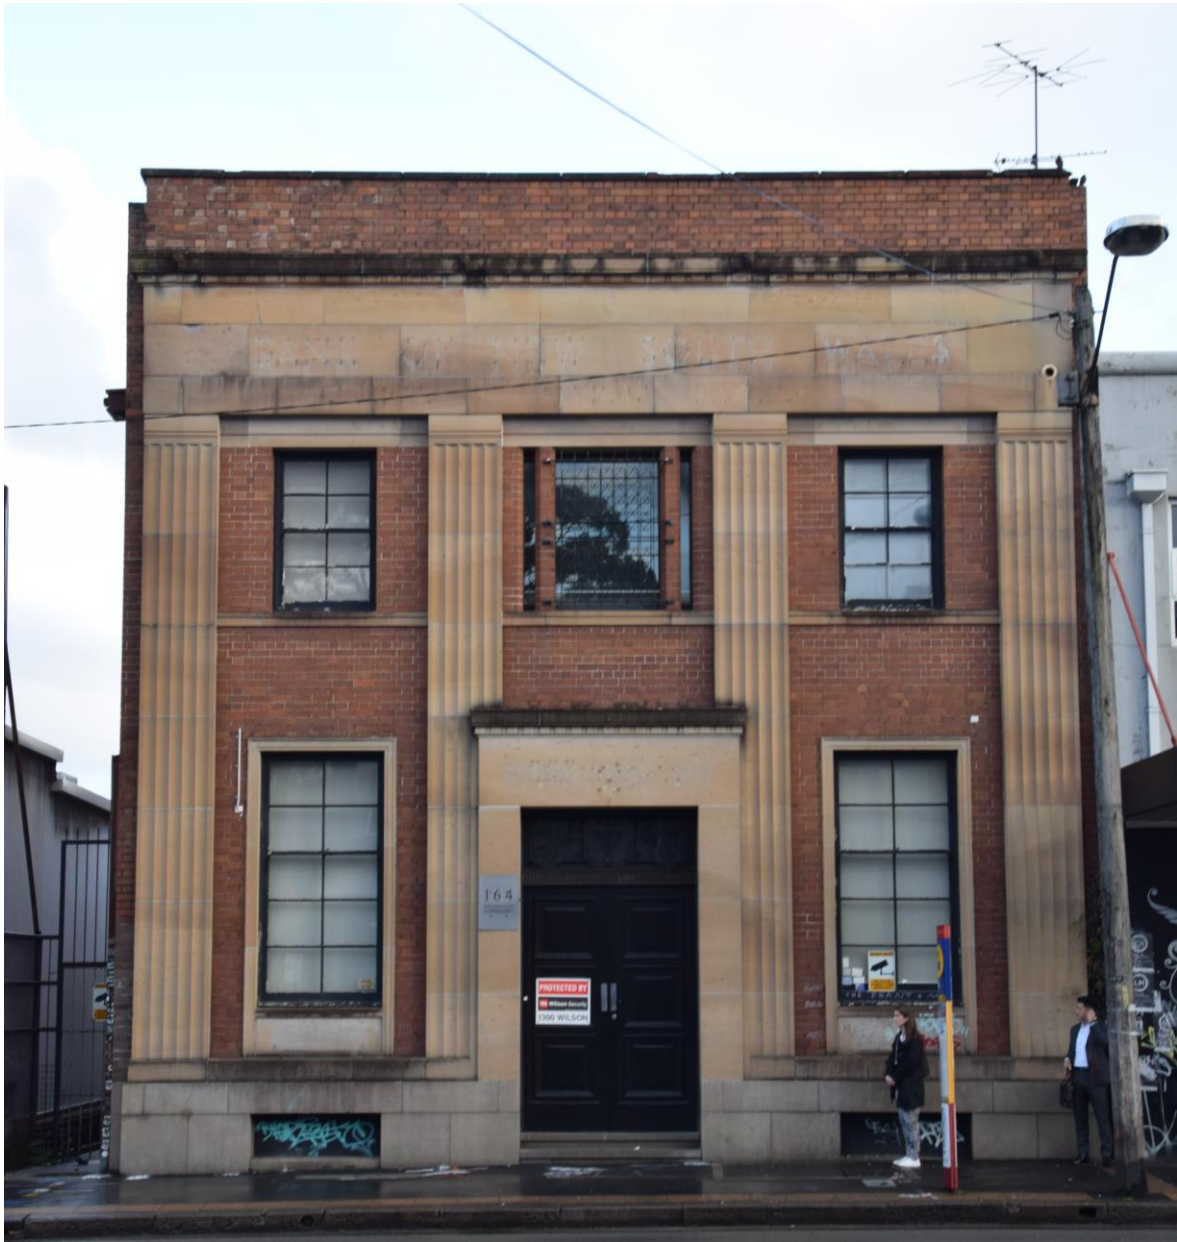
Photograph 1: Main elevation of building

The façade is generally in good condition, although there is some deterioration to the more exposed elements at parapet and cornice level. There is also evidence of a lack of maintenance, as shown by the poor condition of paint and glazing putty to the timber window frames.
