# Arboricultural Impact Assessment

WESTCONNEX NEW M5  
ITS COMMUNICATION CONDUITS & FOOTPATH  
MARSH ST INTERCHANGE & WEST PRINCES HIGHWAY

*CDS reference: M5N-ES-RPT-ARN-0030*

# NOVEMBER 2019

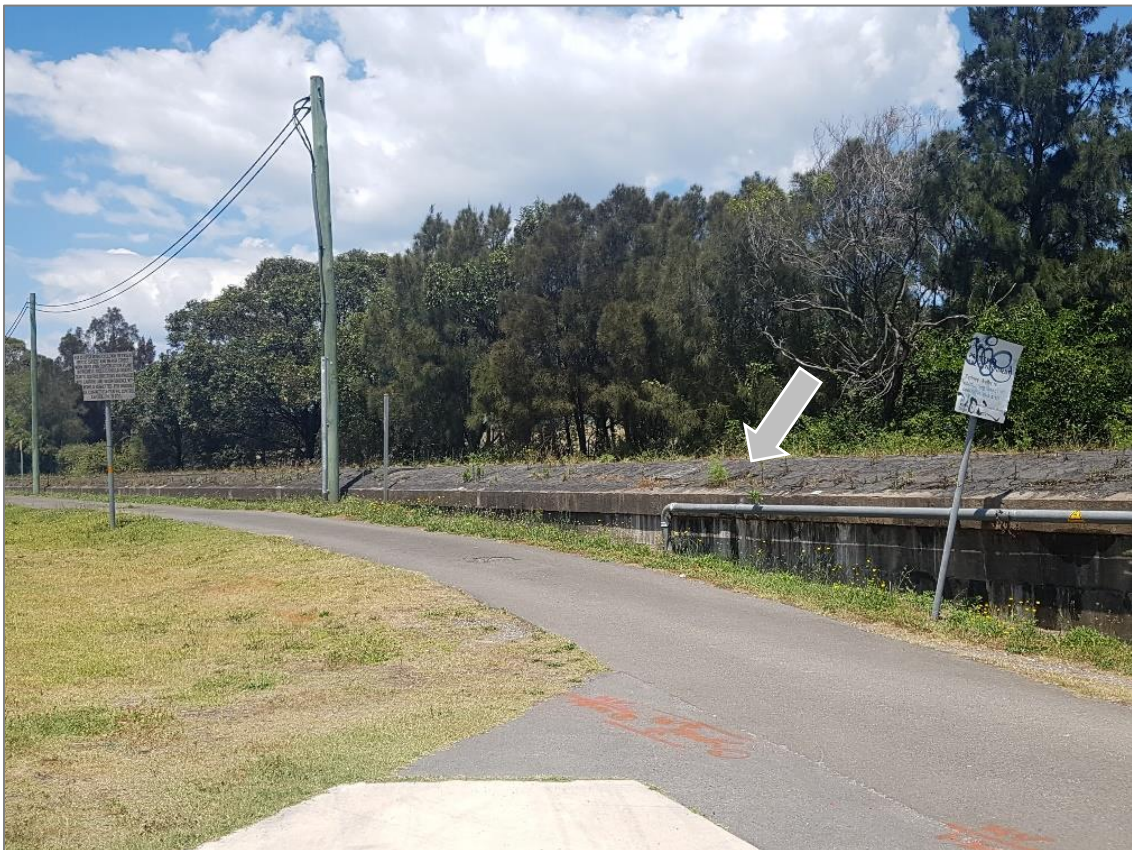
- Trench along the SWSOOS: As this is a heritage listed Sydney Water asset additional approval is required to work near the asset. Furthermore, the coverage levels required for the ITS to meet RMS standard are not achievable. Plate 1 below shows the SWSOOS looking east from Marsh Street and it depicts the decrease in ground level.

Plate 1 – Arrow notes SWSOOS, note the ground level change.

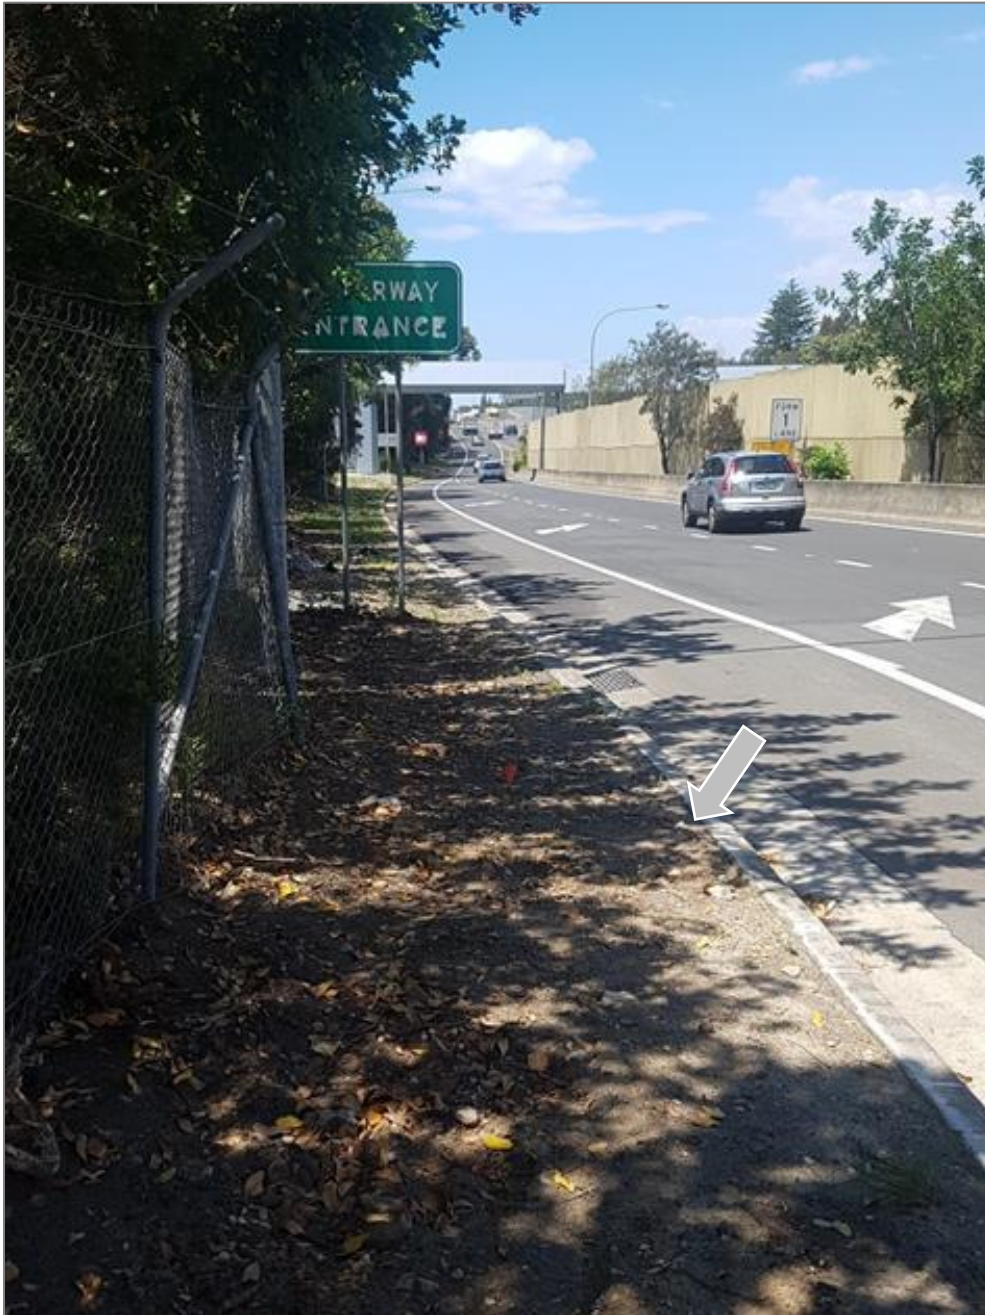
- Trench along M5 on ramp: This option will utilise an existing cleared route. The trench will be positioned as close as possible to the current kerb maximising distance to trees in order to minimise tree root disturbance. See Plate 2 below/next page showing relatively cleared route for northern section of on-ramp.

Plate 2 – Arrow notes existing area clear of vegetation.

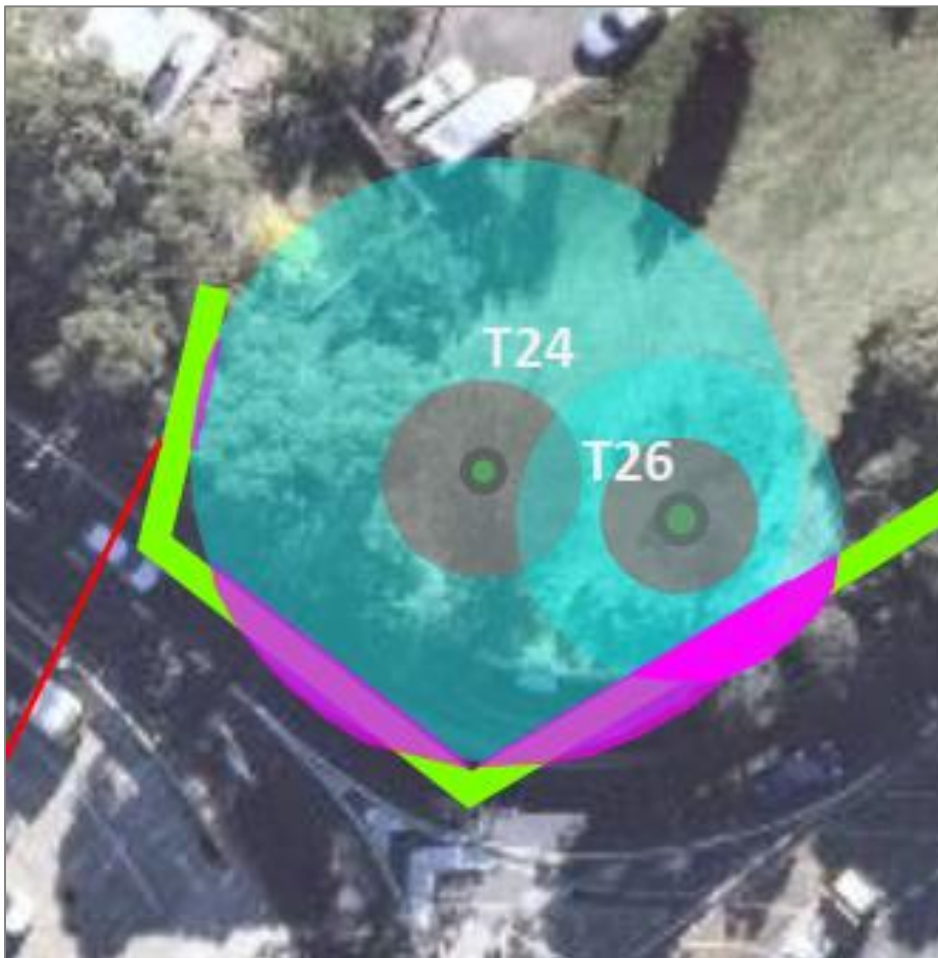
#### 2.4.22 Tree 26 – Red Mahogany

- Structural Root Zone impacts: The proposed works are located outside the calculated SRZ of this tree.
- Tree Protection Zone impacts: Proposed works will incur a theoretical 5.4m<sup>2</sup> or 7.5% encroachment into the TPZ of this specimen (see Figure 2 below/next page). Under AS4970, encroachments less than 10% are considered minor. This level of encroachment is unlikely to negatively affect tree health and condition.
- Pruning impacts: No pruning is foreseen to accommodate the proposed works.

**Figure 2** – Tree 24 & T26. Blue shaded circle denotes TPZ, red shaded circle SRZ. Bright pink shading shows proposed encroachment from trenching. Marked up aerial photograph by C Hughes.

T26	<i>Eucalyptus resinifera</i> ? <b>Red Mahogany</b>	12	6	400	M	F	P	Native species, likely locally native species. High percentage of deadwood and epicormic growth noted	3A	M	L	2.3	4.8	72
T27A	<i>Olea europaea</i> subsp. <i>europaea</i> <b>Feral/European Olive</b>	8	6	100	EM	G	G	Olive is a declared weed under the Biosecurity Act 2015.	2C	L	L	1.7	2.4	18
G27	<i>Acacia saligna</i> <b>Golden Wreath Wattle</b> <i>Eucalyptus</i> sp. <b>Gum X 1</b>	8	6	75-200	M	G	G	Introduced native species, known to have a weed-like habit. No special problems noted at time of assessment. The small Gum has a 75mm diameter stem.	2C	L	L	1.7	2.4	18
T28	<i>Eucalyptus resinifera</i> ? <b>Red Mahogany</b>	16	14	600	M	G	G-F	Native species, likely locally native species. High percentage of large diameter deadwood noted, sprawling specimen.	1A	M	H	2.7	7.2	163
T29	<i>Eucalyptus</i> sp. <b>Gum</b>	16	14	*500	M	G	F	Native species. Tree surrounded by tall, dense weeds, unable to access stem.	1A?	M	H	2.5	6.0	113

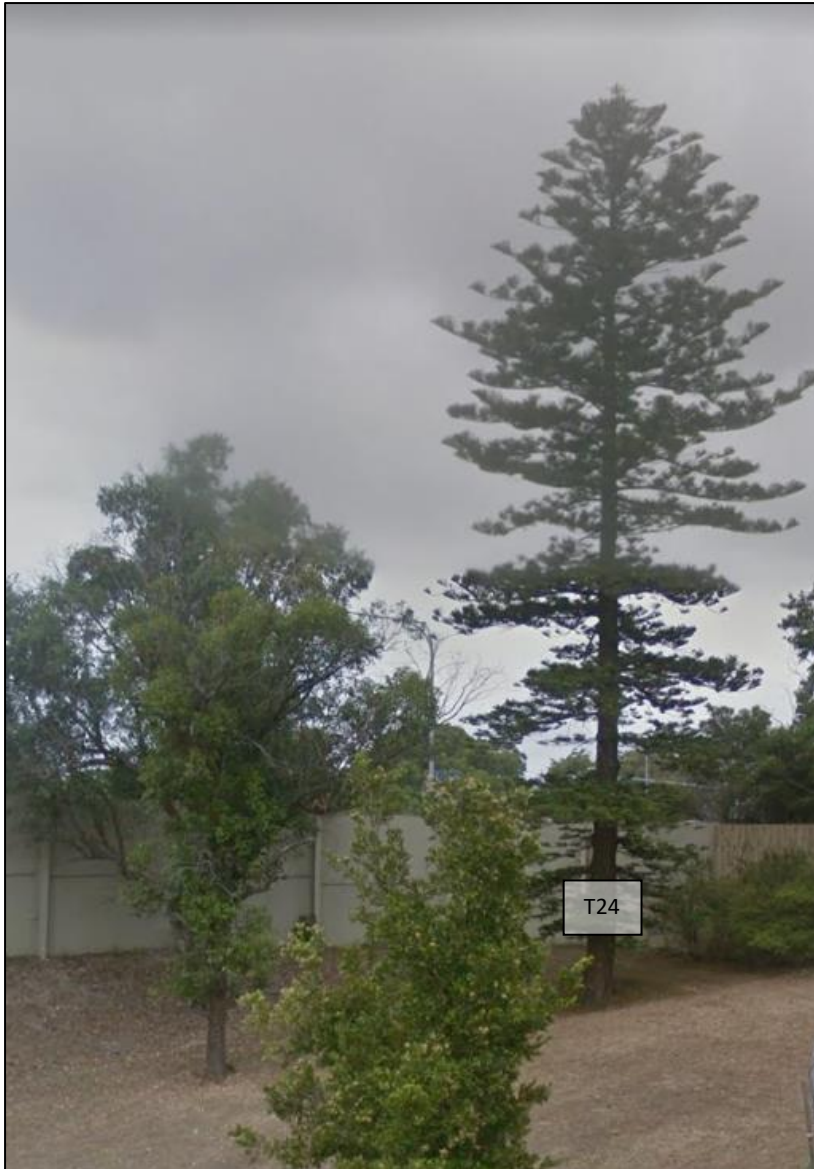
Plate 1- Google Maps Street View capture of T24 Norfolk Island Pine. This tree is a significant tree in good health and condition.

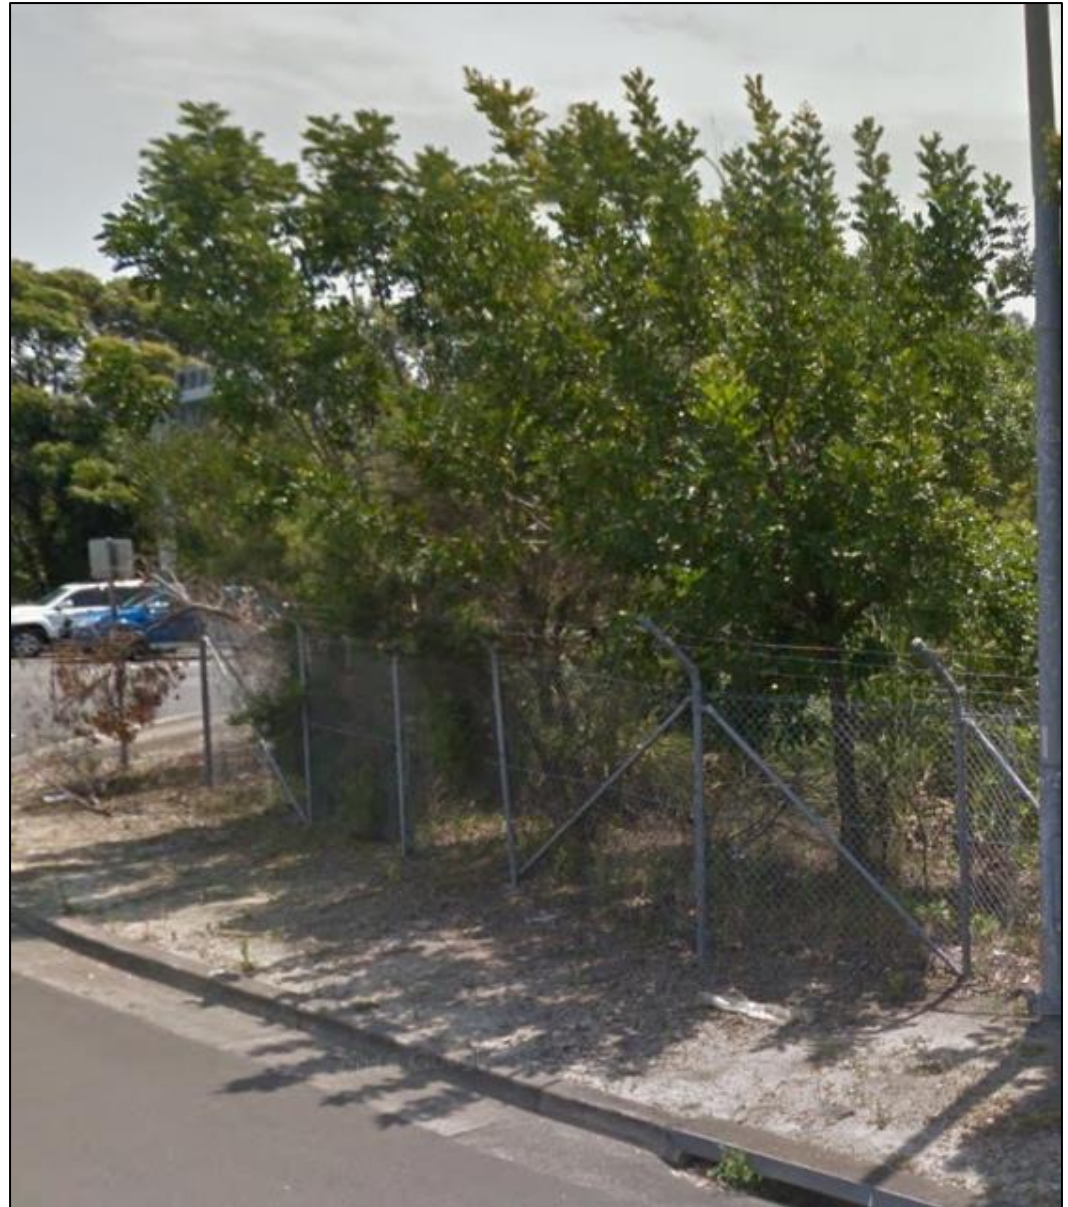
Plate 2 – Google Maps Street View noting a section of G39. A planted row of established Tuckaroo.

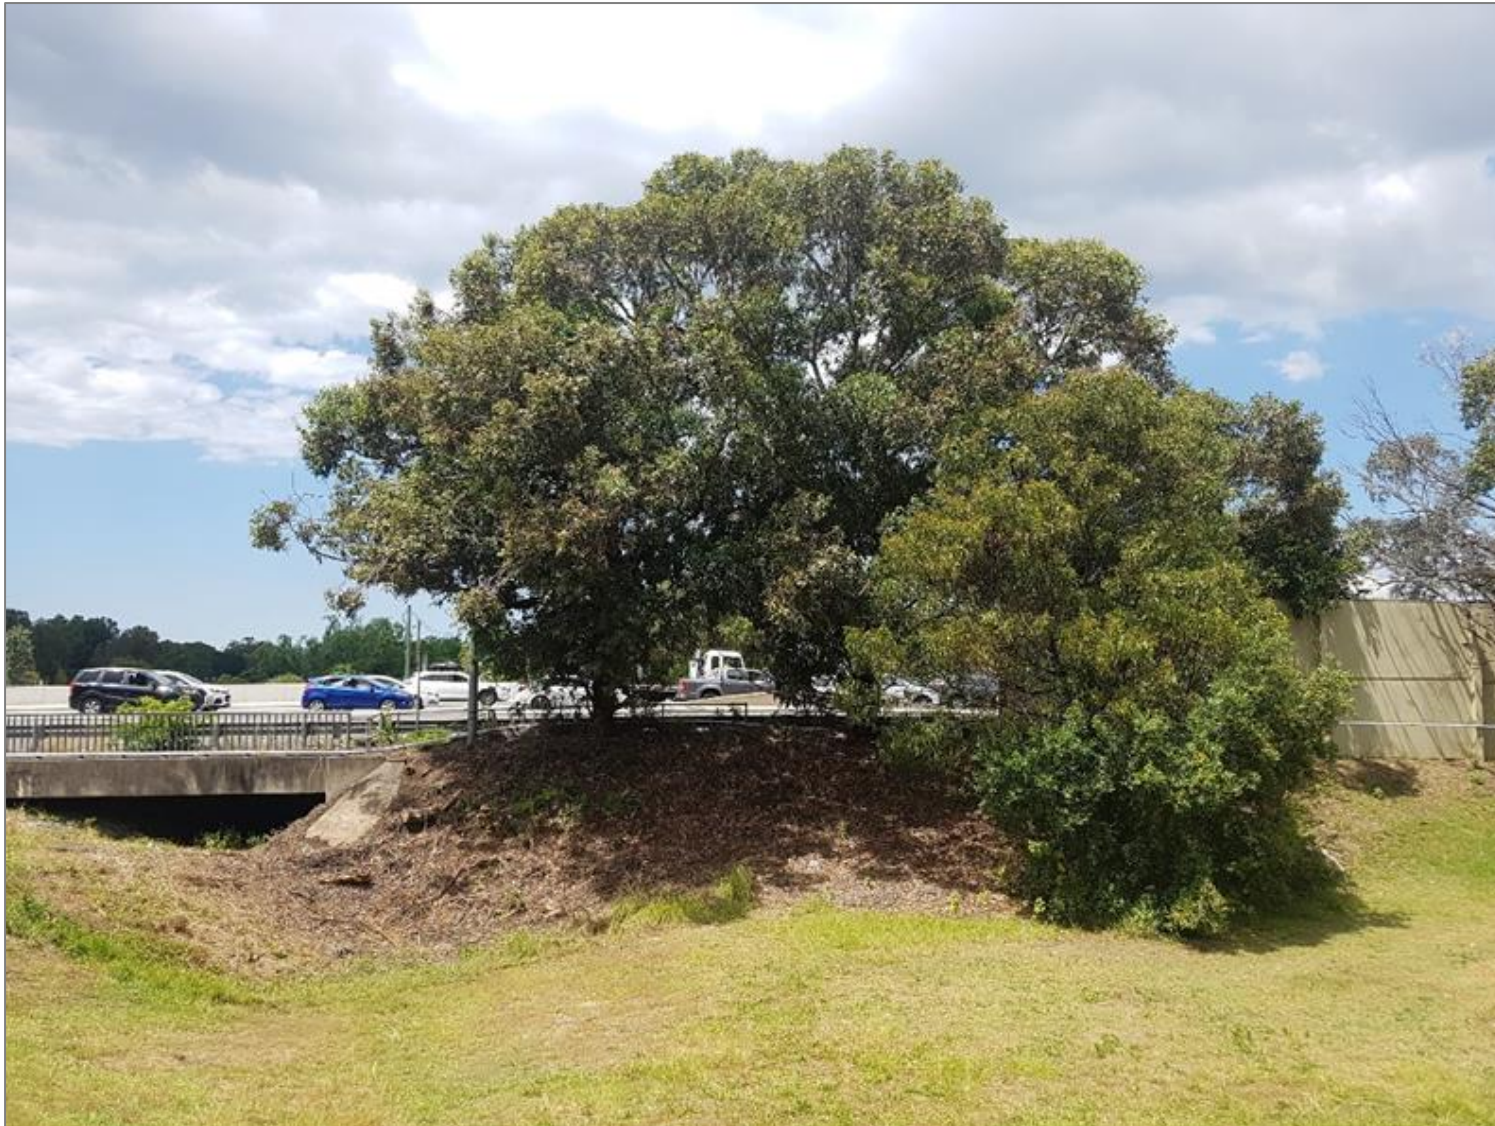
Plate 3 –Trees 28 & T29 are highly visible and in good health leading to a high Retention Value (RV).

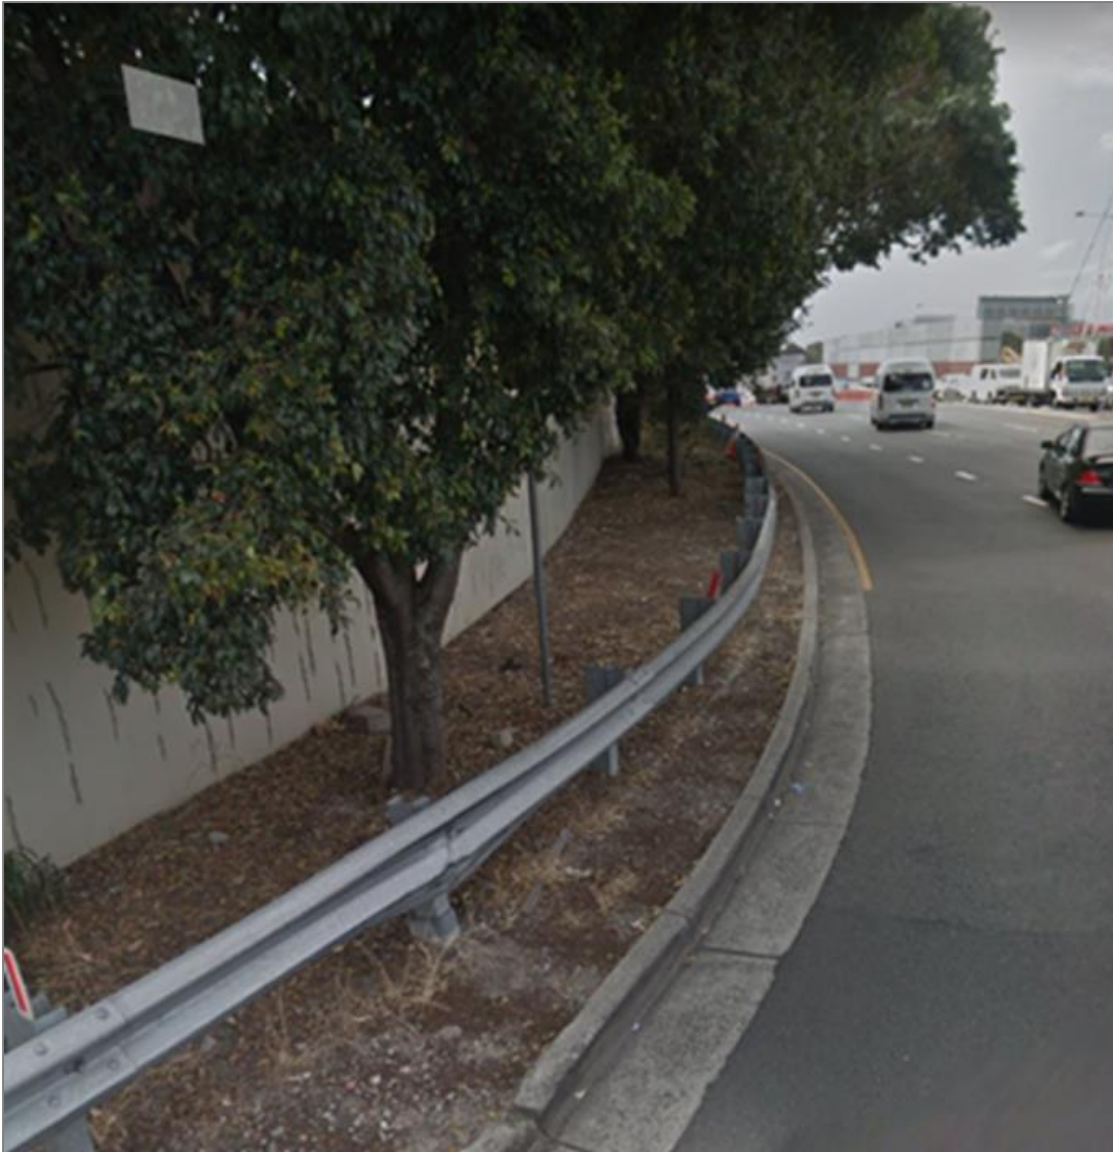
Plate 4 – Google Maps Street View  
noting T32 & T33
