Arboricultural Impact Assessment

Westconnex New M5
Traffic Intersection
Gardeners Rd, MASCOT

CDS reference: M5N-ES-RPT-LRW-0049-00-Gardeners Road CH100 Tree Report

February 2019

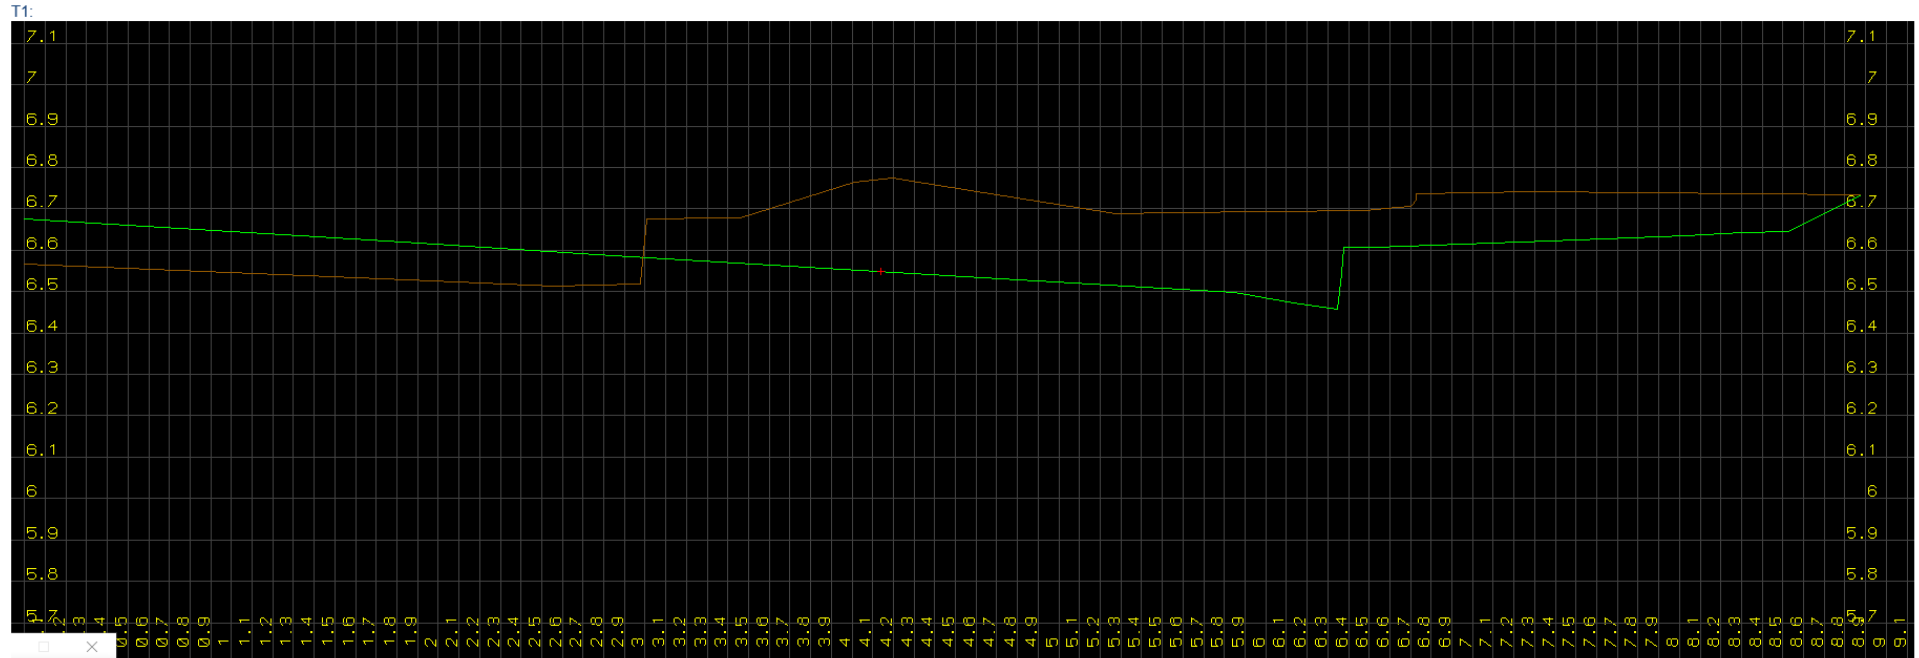
Figure 1 – T1 - Brown line denoted existing ground level, green line is proposed/finished ground level, red cross is tree location.

Given all four (4) trees are within the footprint of the proposed works and will be subjected to significant ground level reductions within the Structural Root Zones (SRZ) (see Appendix F), they cannot be safely retained.

Soil level changes are unacceptable within the SRZ of trees, lowering ground levels will incur major root severance and render the trees unstable.

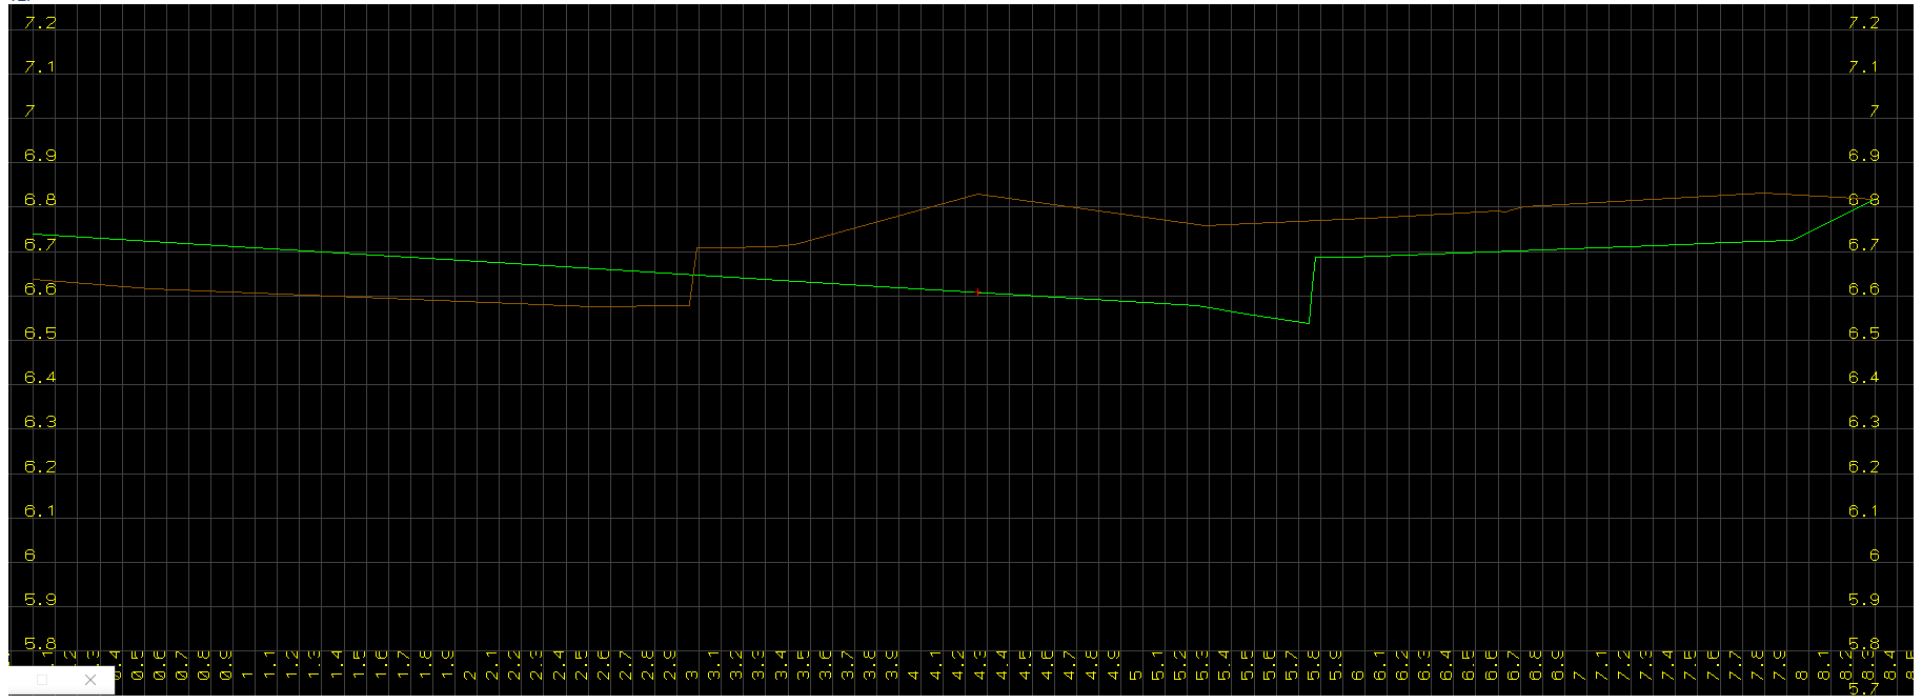
T2:

Figure 2 – T2 - Brown line denoted existing ground level, green line is proposed/finished ground level, red cross is tree location.

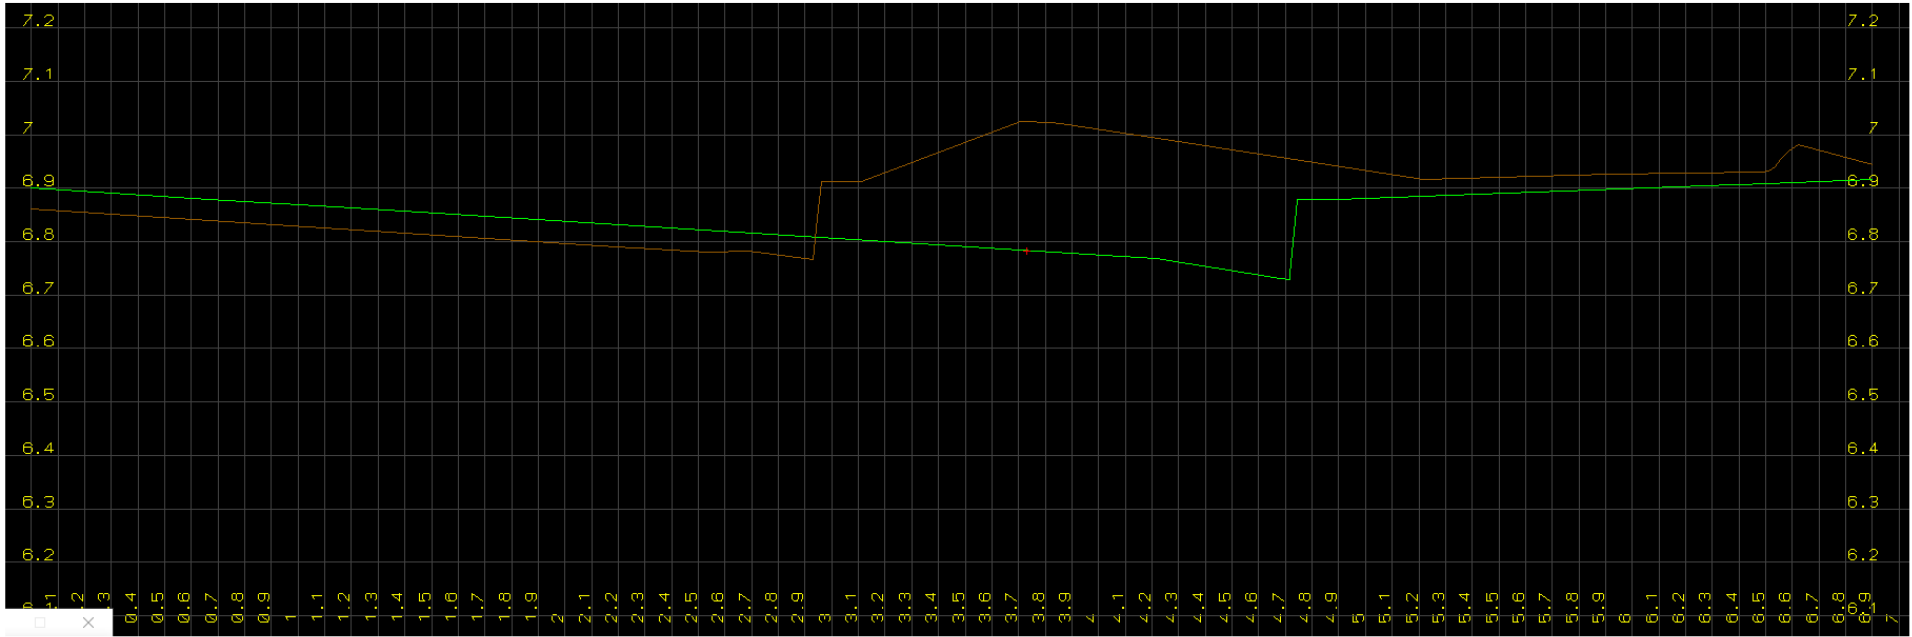
T3:

Figure 3 – T3 - Brown line denoted existing ground level, green line is proposed/finished ground level, red cross is tree location.

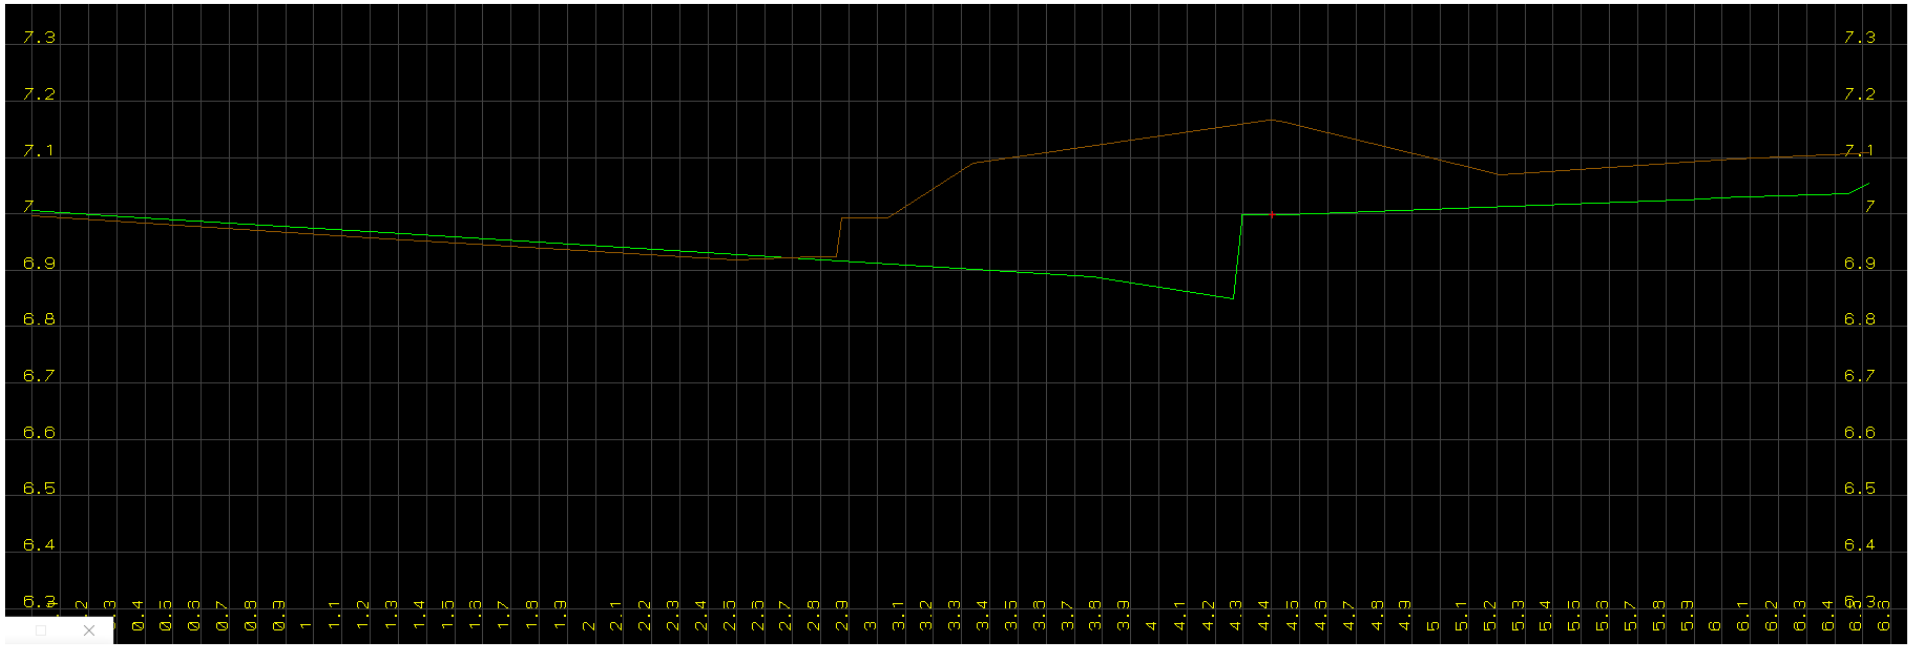
T4:

Figure 4 – T4 - Brown line denoted existing ground level, green line is proposed/finished ground level, red cross is tree location.

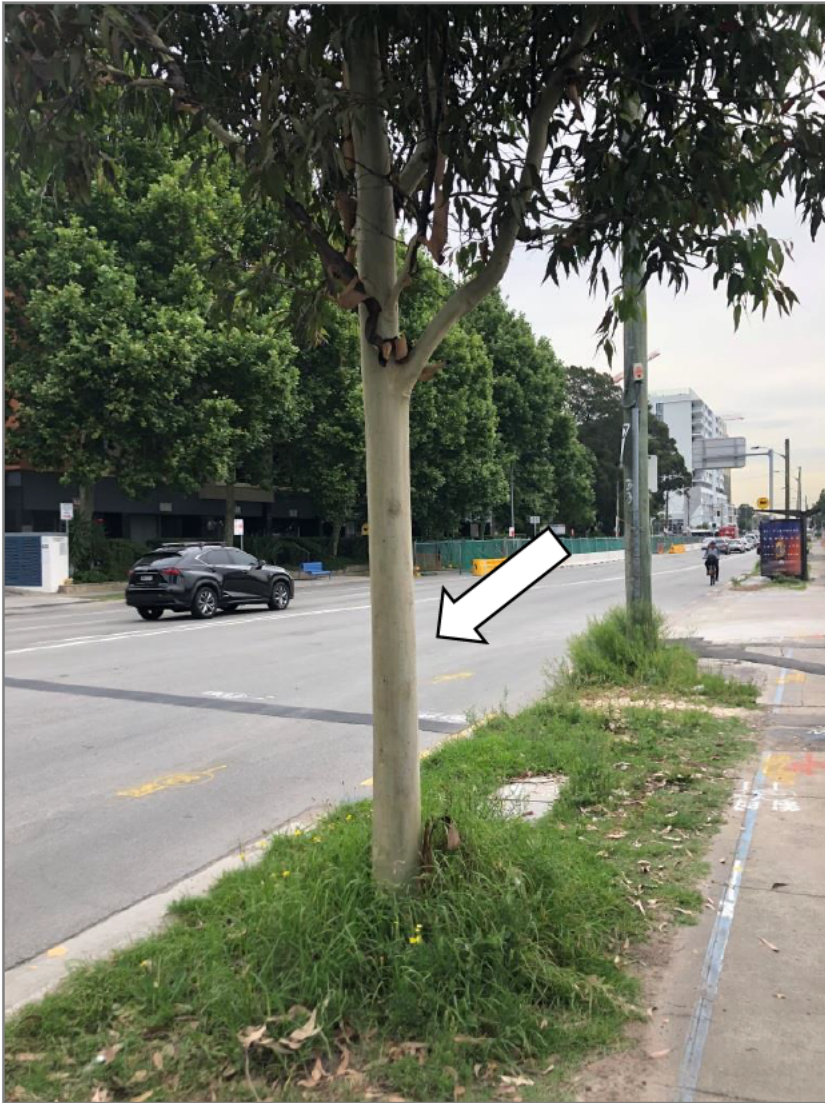
Plate 1 – Arrow notes stem of T1. Trees growing in existing narrow verge.

Four (4) trees ascribed a *medium* RV require removal to accommodate the proposed works (T1-T4).

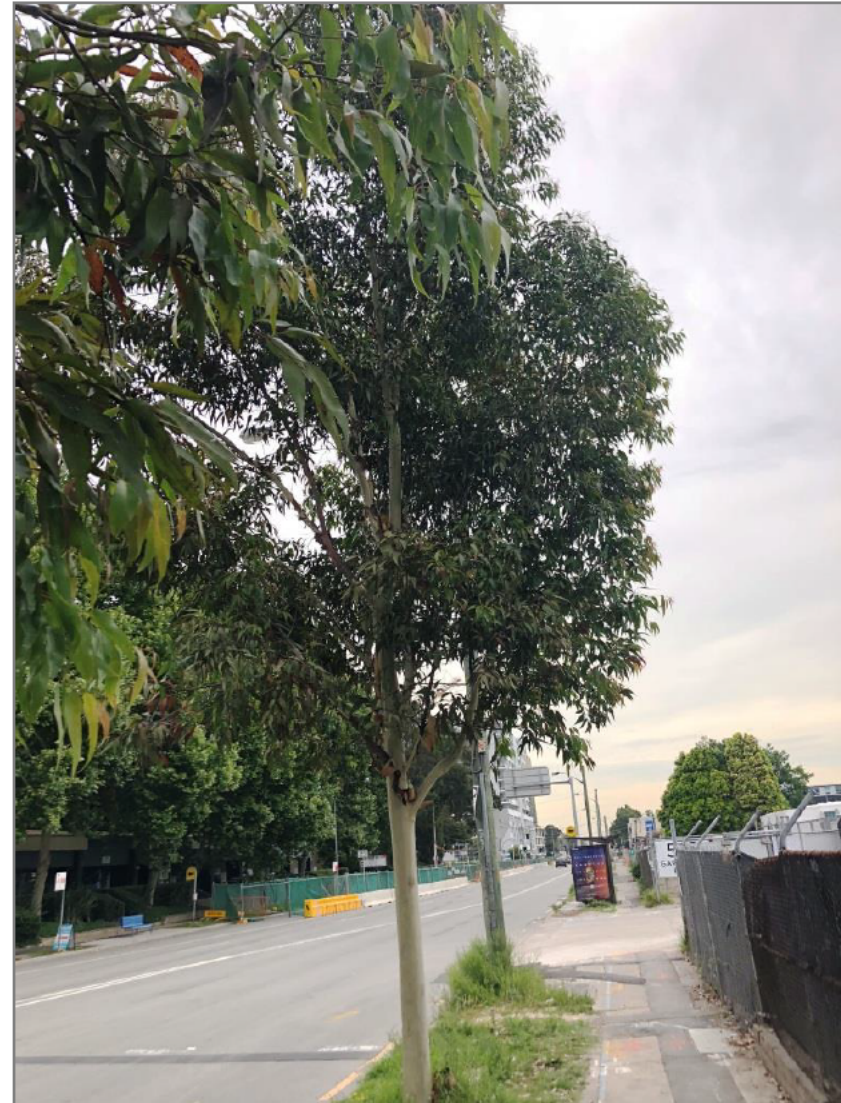
Plate 2 – Tree 1 – upper canopy of this tree noted.

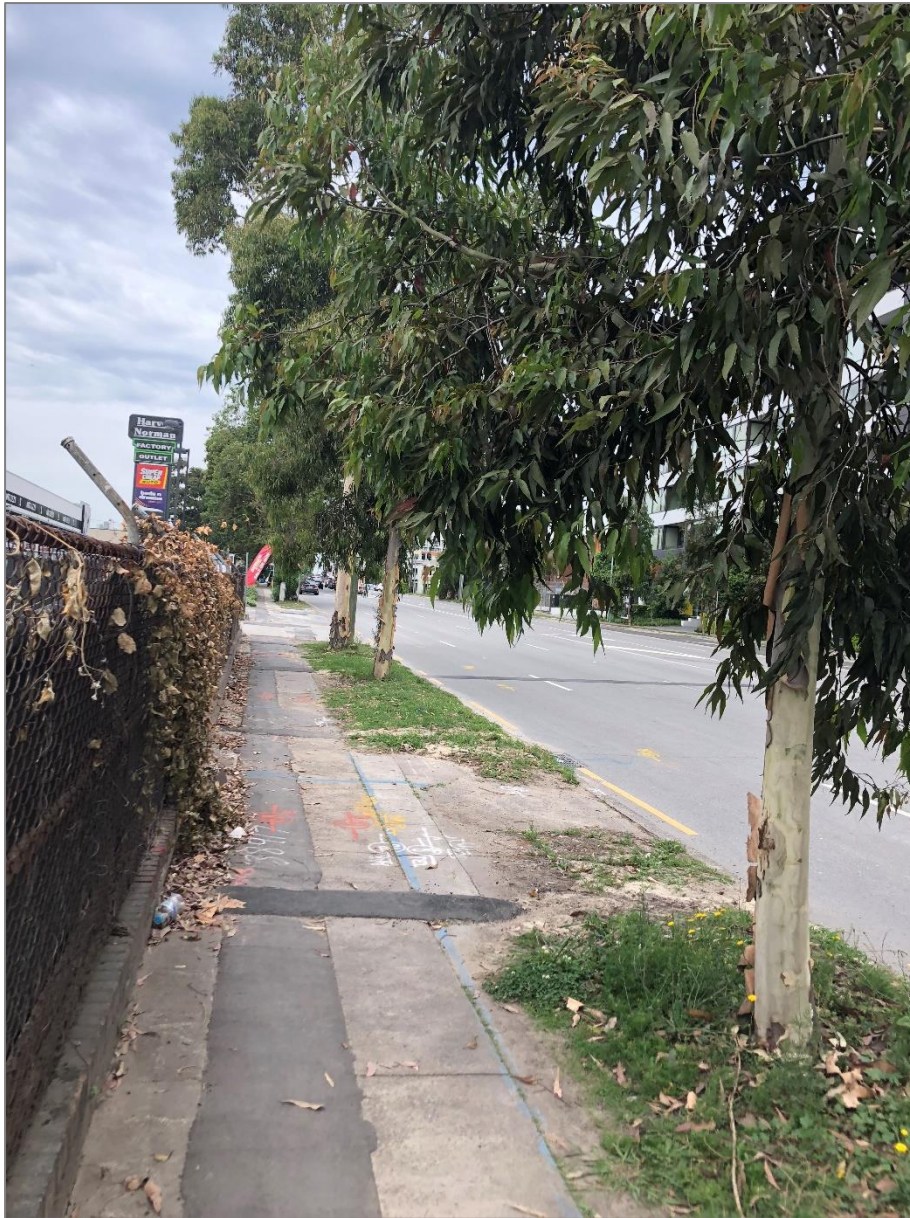
Plate 3 – Trees 2-4. T2 closest, onwards to T4.

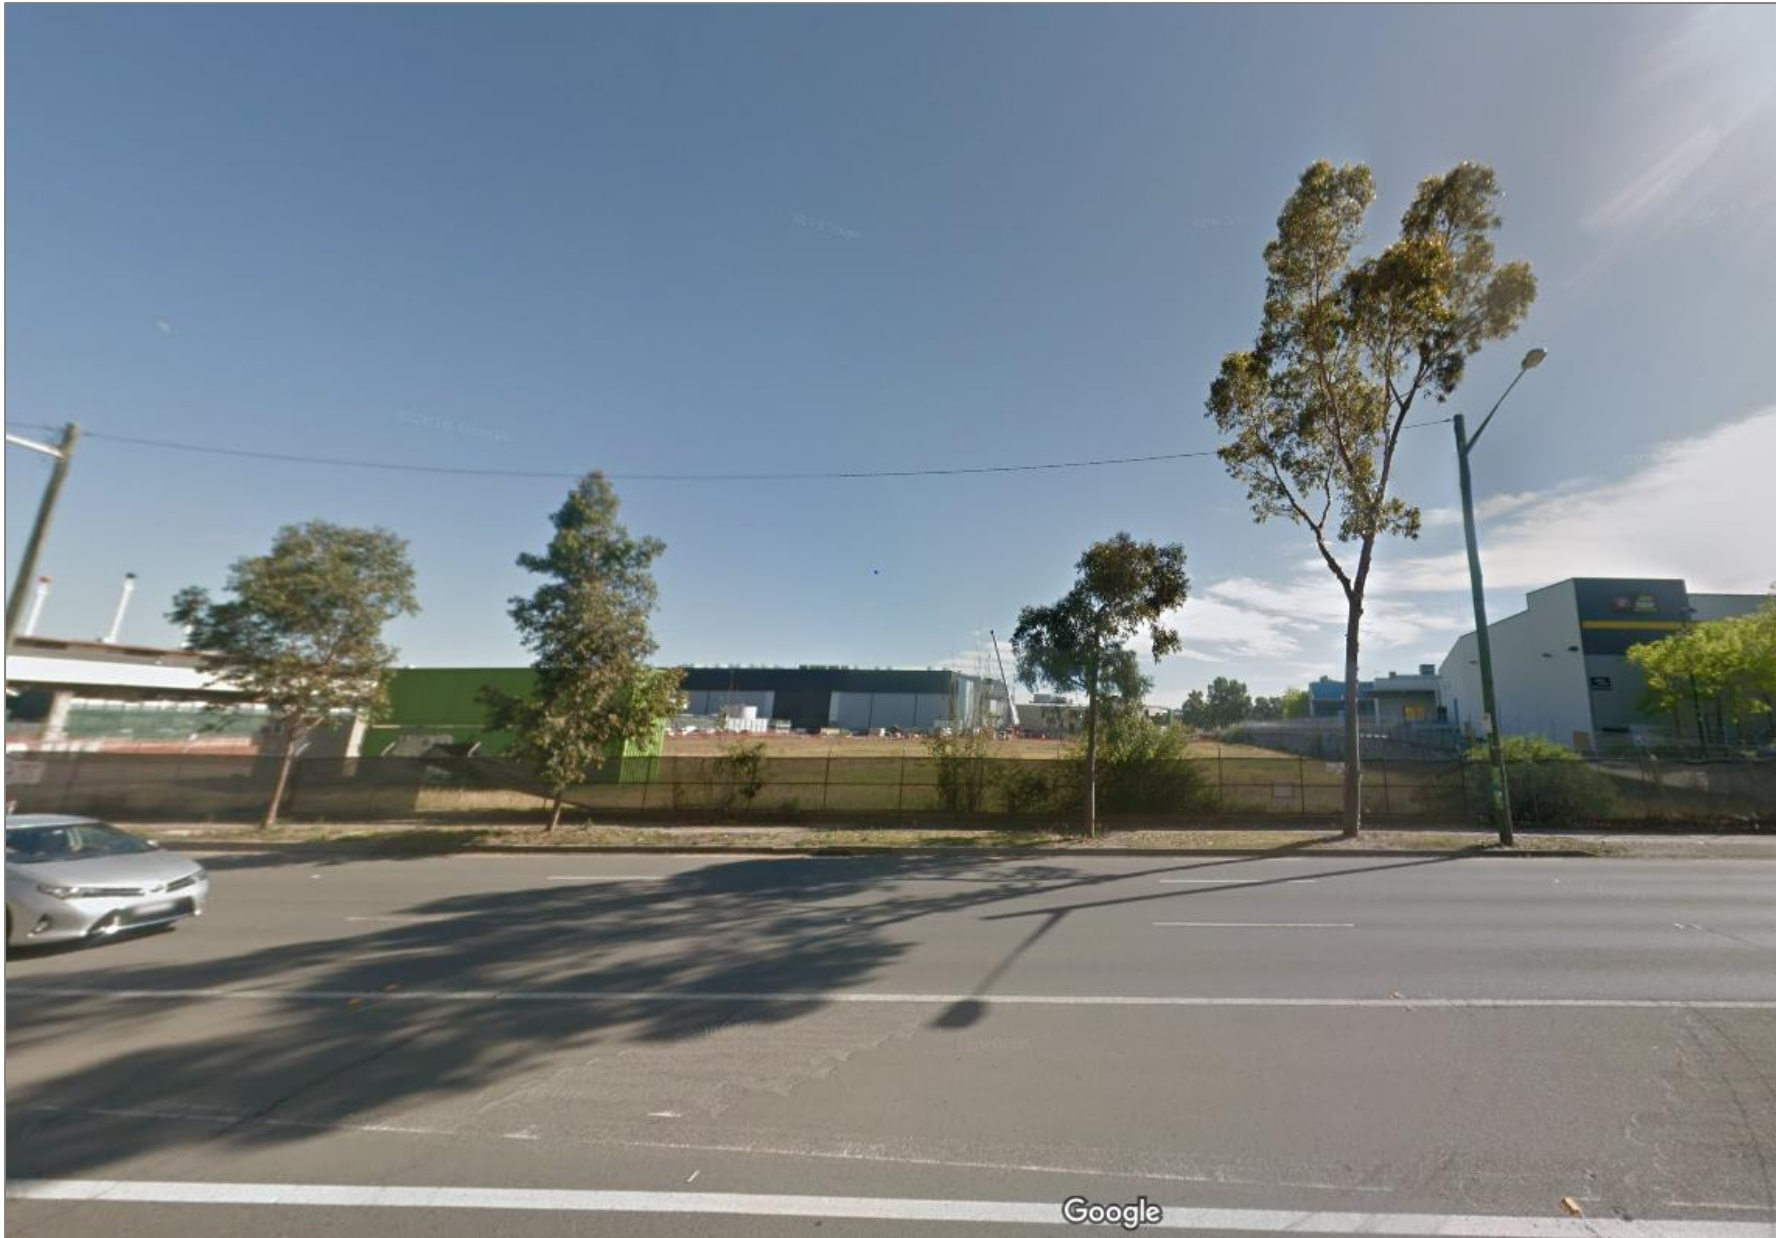
Plate 4 – Trees 1-4 left to right. Photograph courtesy of Google maps street view 12/2/2019.
