## RUDDERS BOND STORE / FORMER SYMONDS FACTORY

### Preliminary Conservation Strategy

Post-Salvage Phases

August 2016

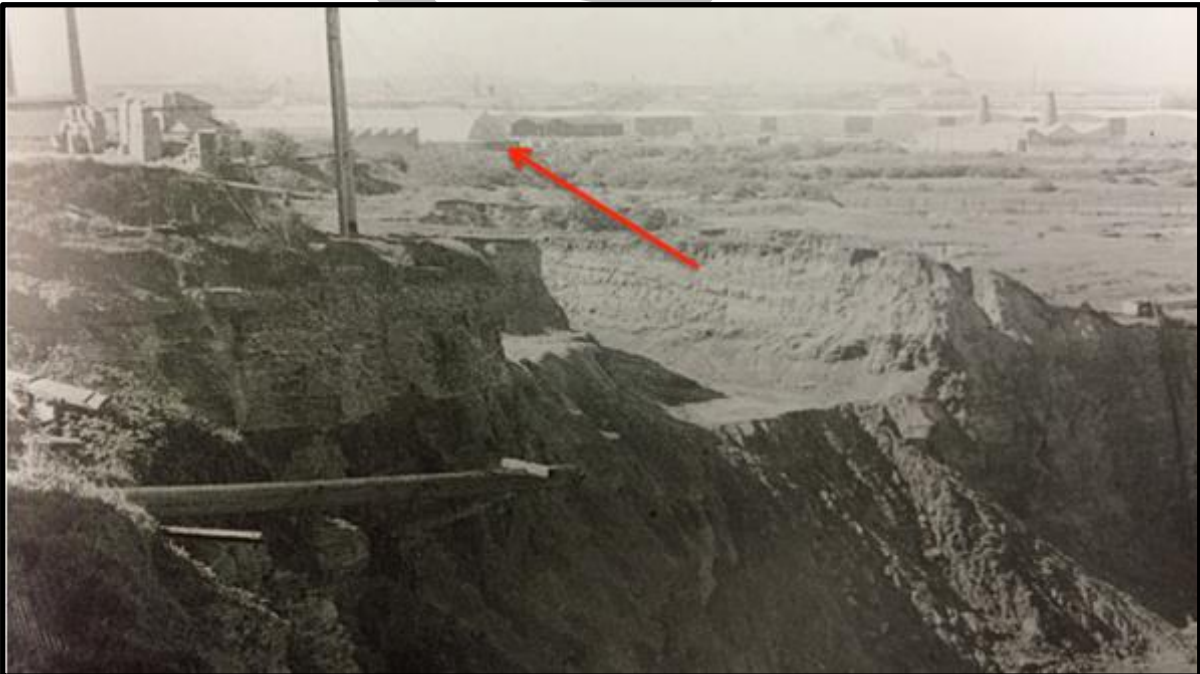
**Figure 4 – The Austral pit which was shared by The Central Brick & Tile Co Pty Ltd. The first building on the subject site can be seen in the background (indicated by red arrow).**

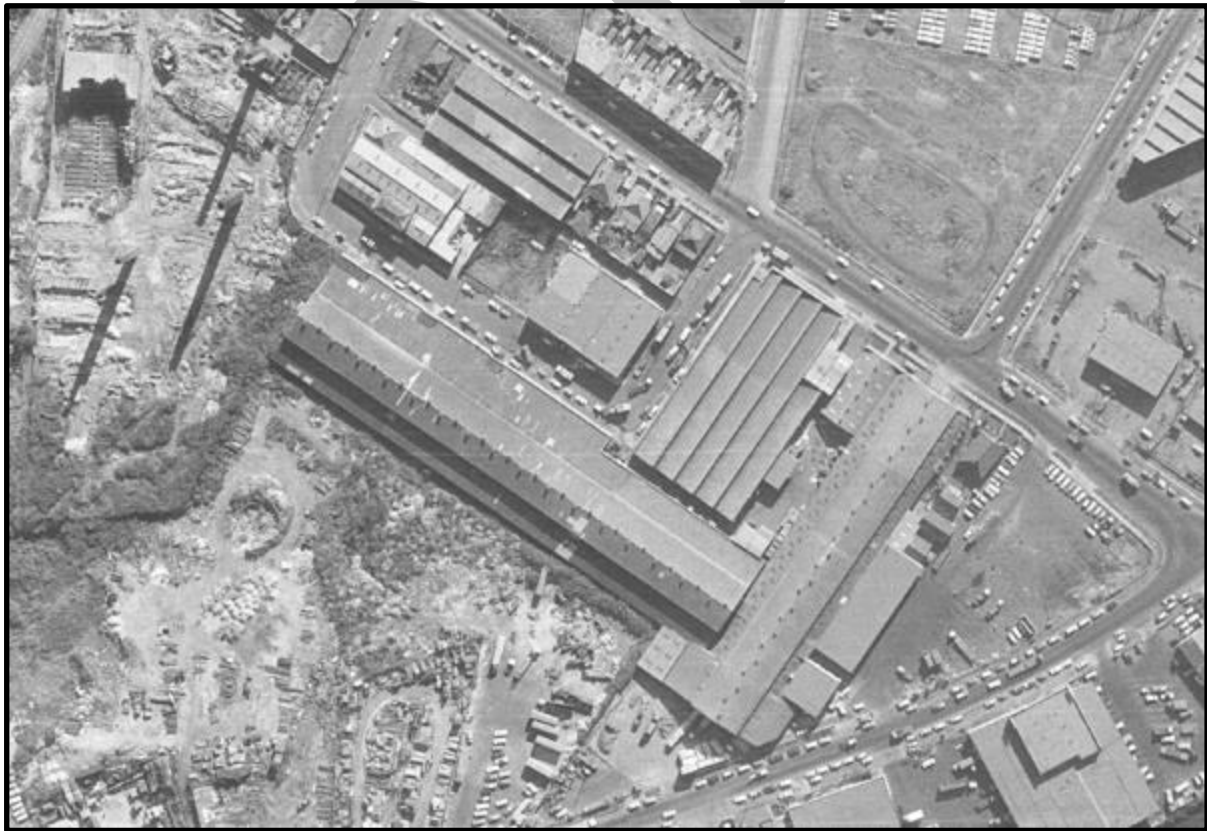
**Figure 8 - Aerial photograph, 1970. Shows full building as per early 1950s planned layout. (Source: NSW Department of Lands).**

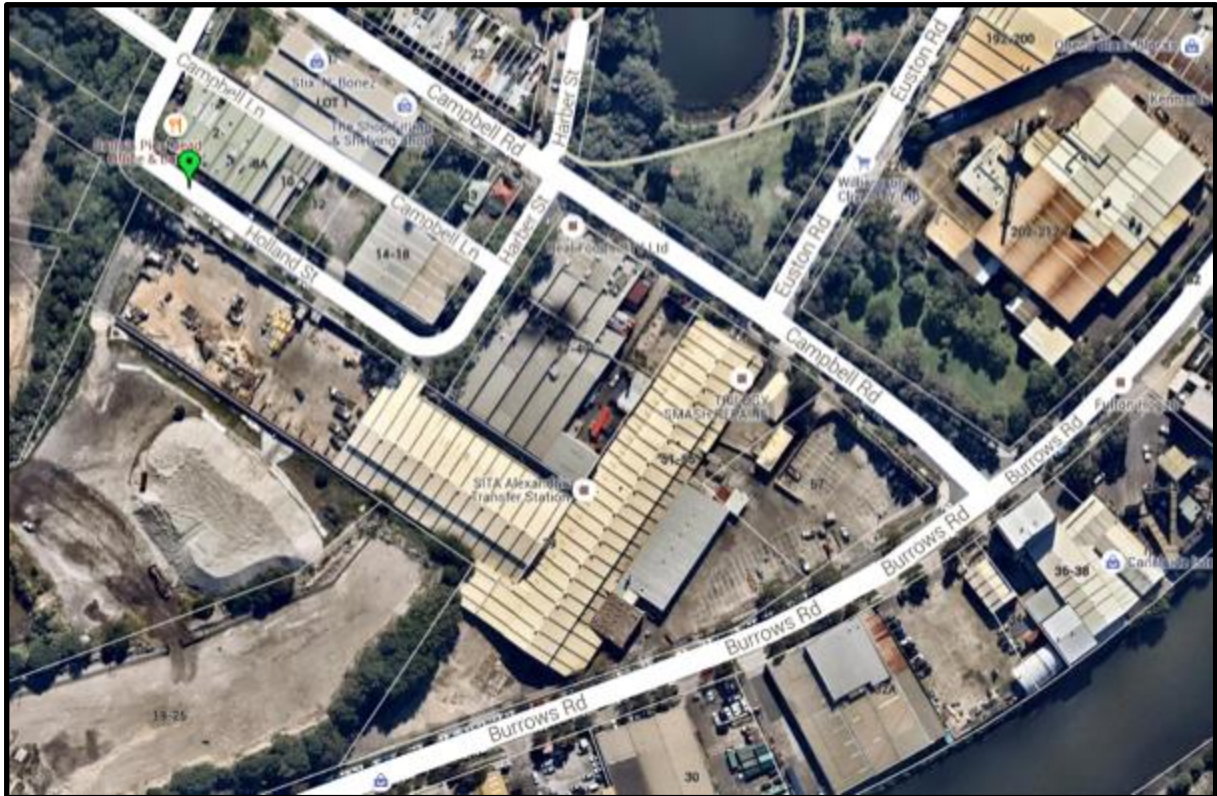
Figure 11 - Subject site 2016. Shows current extent of the building. The Holland Street arm has been shortened, reducing it in length by half. (Source: Nearmaps, 2016).

Overall the building is in good condition. The larger wing (fronting Campbell Street) is constructed of 25 arches, while the truncated building fronting Holland Street now consists of only 15 arches. There are presently 40 arches in total.
