Arboricultural Impact Assessment

Marsh Street Wetlands
ARNCLIFFE NSW 2205

Revision 4

MAY 2017

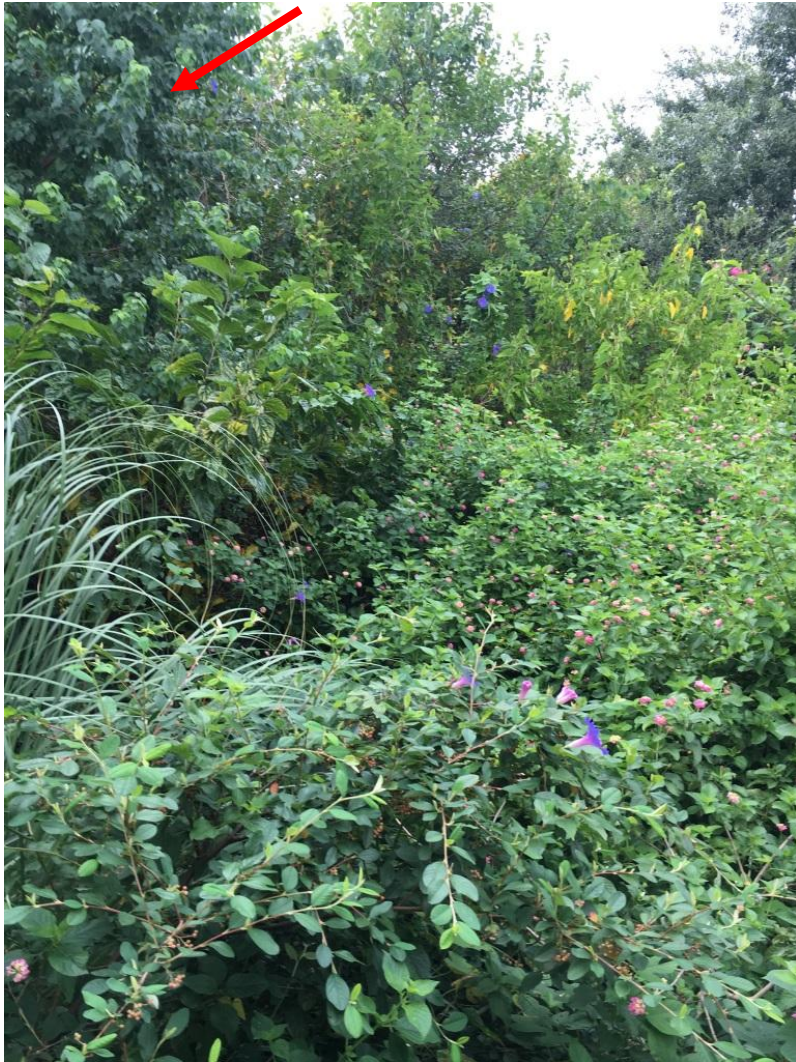
Group 11 includes one (1) noxious weed species (*Sapium/Triadica sebiferum* Chinese Tallow) and three (3) *Morus* sp. Mulberry among other weedy shrubs and vines, all which appear to have self-sown along the stormwater easement. This group has been attributed a 'Low' Retention Value (RV – see Appendix C). Removal of this group is required due to the instalment of water piping, pump sump and for the previously discussed perimeter fence as per design features set out by CDS-JV Design Team ([REDACTED] CDS-JV Design Manager). These works will be within the SRZ and TPZ of these trees.

Photo 1 – Group 11, tree noted with red arrow is Chinese Tallow wood, noxious weed.

Four (4) of the six (6) prescribed trees/tree groups (Tree 3, 5, 6 & Group 11) are required to be removed to accommodate the proposed works considering the current design follow advice as per Ecological Report - Habitat Creation and Captive Breeding Plan (HCCBP) - Green & Golden Bell Frog at Arncliffe, Part 2.4.1-2.4.3.

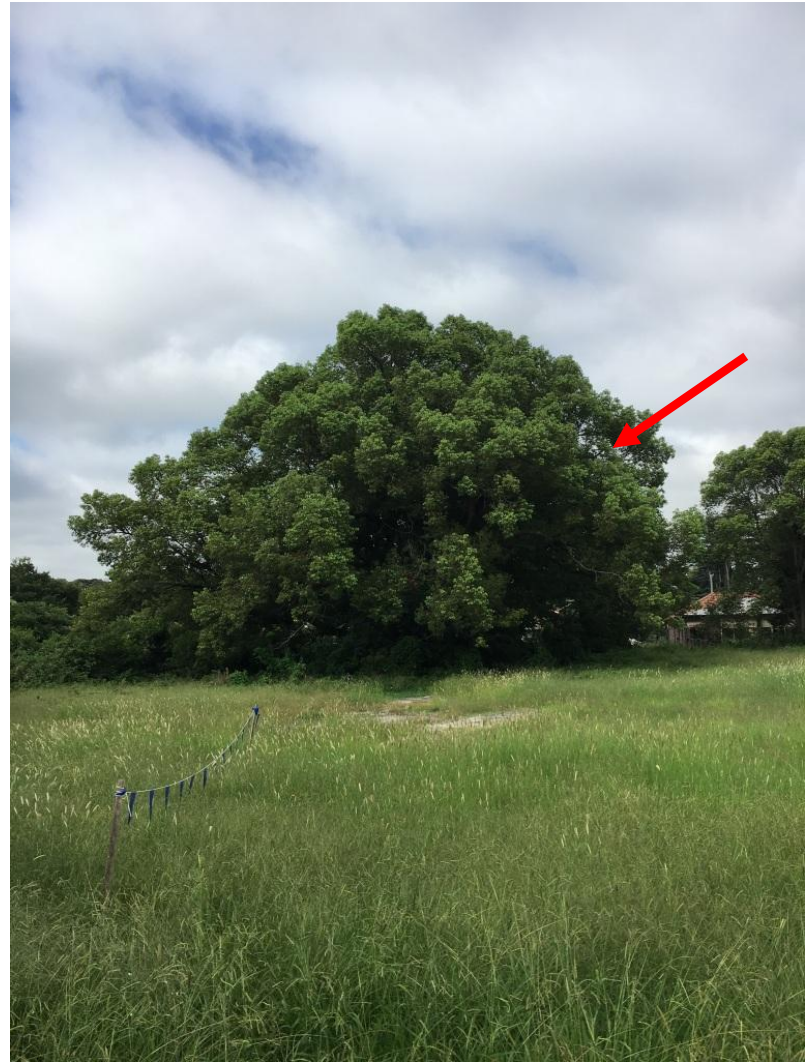
Five (5) of the assessed trees (Tree 4, 7-10) were identified as *Cinnamomum camphor* (Camphor laurel). Although these trees are mature and healthy they are a declared noxious weed species and have been attributed a 'Low' Retention Value (RV – see Appendix C).

These five (5) trees require removal at the subject site due to comments provided by [REDACTED] (Project Herpetologist, [REDACTED] Consultants) regarding the identified toxicity produced in their leaves having an adverse affect on the establishment, and ongoing longevity, of the Green and Golden Bell Frog population. [REDACTED] also stated that overshadowing of the proposed ponds is another issue these trees pose (see Appendix G). Trees 7, 9 & 10 are in the location of the perimeter fencing required to keep the frog population in and intruders out.

Photo 2 – T10. Large, mature Camphor laurel, species is a noxious weed.

Replanting will be undertaken as specified in the HCCBP in accordance with the habitat requirements of the Green and Golden Bell Frog. Five (5) non-prescribed trees (Tree 4, 7-10) are also proposed for removal to accommodate works.

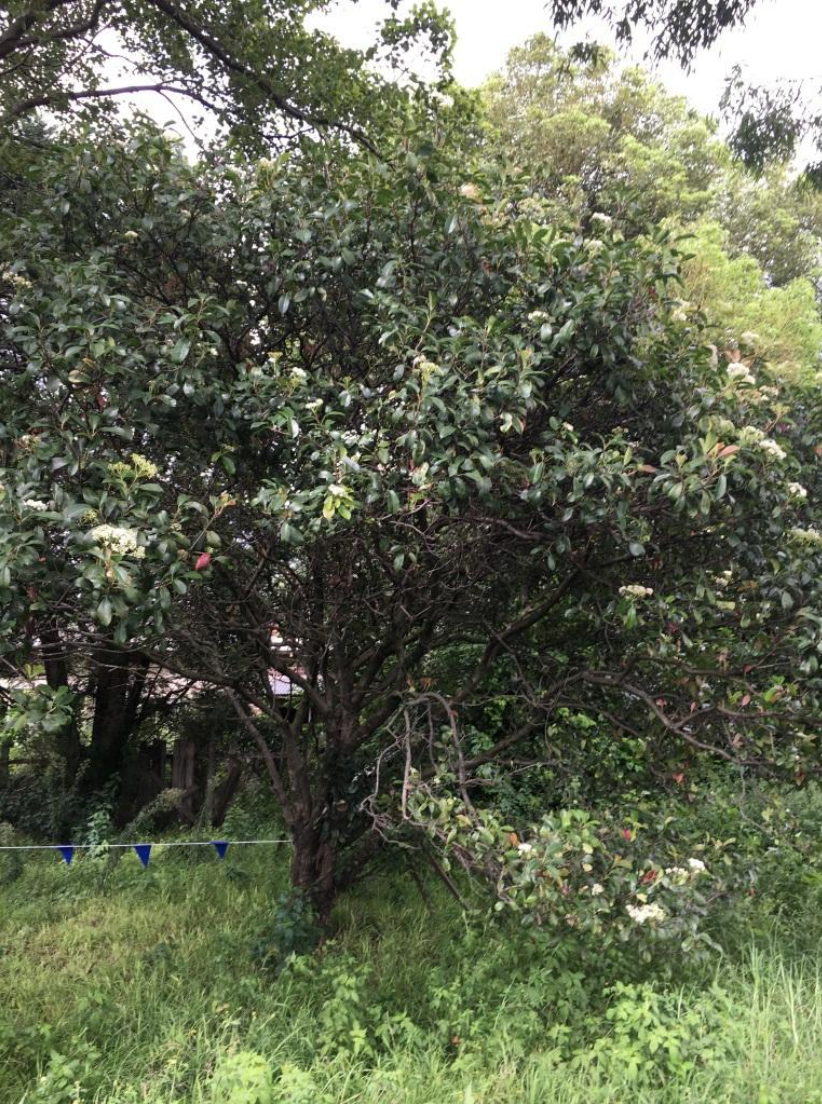
Tree 6 *Photinia x fraseri* 'Robusta' (Chinese Hawthorn) has been attributed a 'Low' Retention Value (RV- see Appendix C) and is proposed for removal. This tree falls within the proposed drainage swale and requires removal under the current proposal.

Photo 3 – Tree 6; Shrub like Chinese Hawthorn.

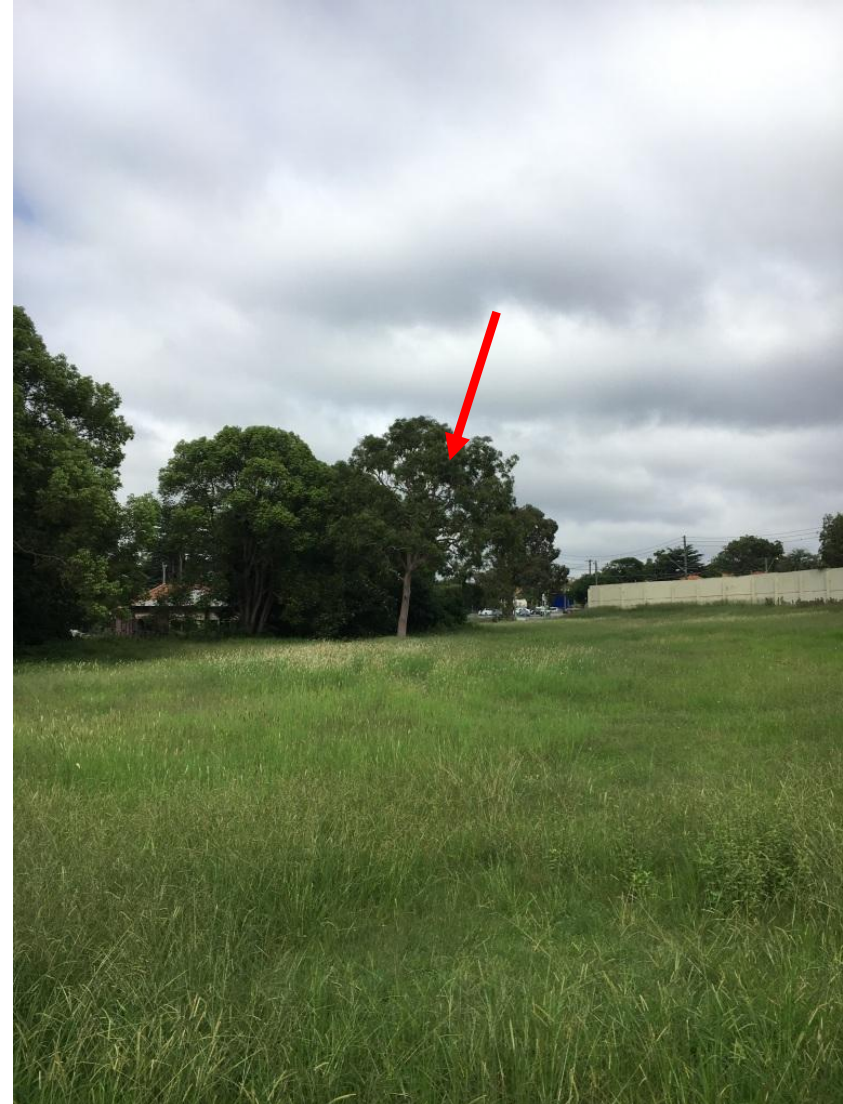
Tree 5 *Corymbia citriodora* (Lemon Scented Gum) has been determined to have a 'High' Retention Value (RV- see Appendix C). The proposed drainage swale and Pond 2 are located within the trees notional SRZ. Additionally the tree will create overshadowing of ponds under the current design, specialist advice states low vegetation is favourable for frog habitat. Under the current proposal it is not possible to retain this tree.

Photo 4 – Tree 5; Lemon Scented Gum noted with red arrow.

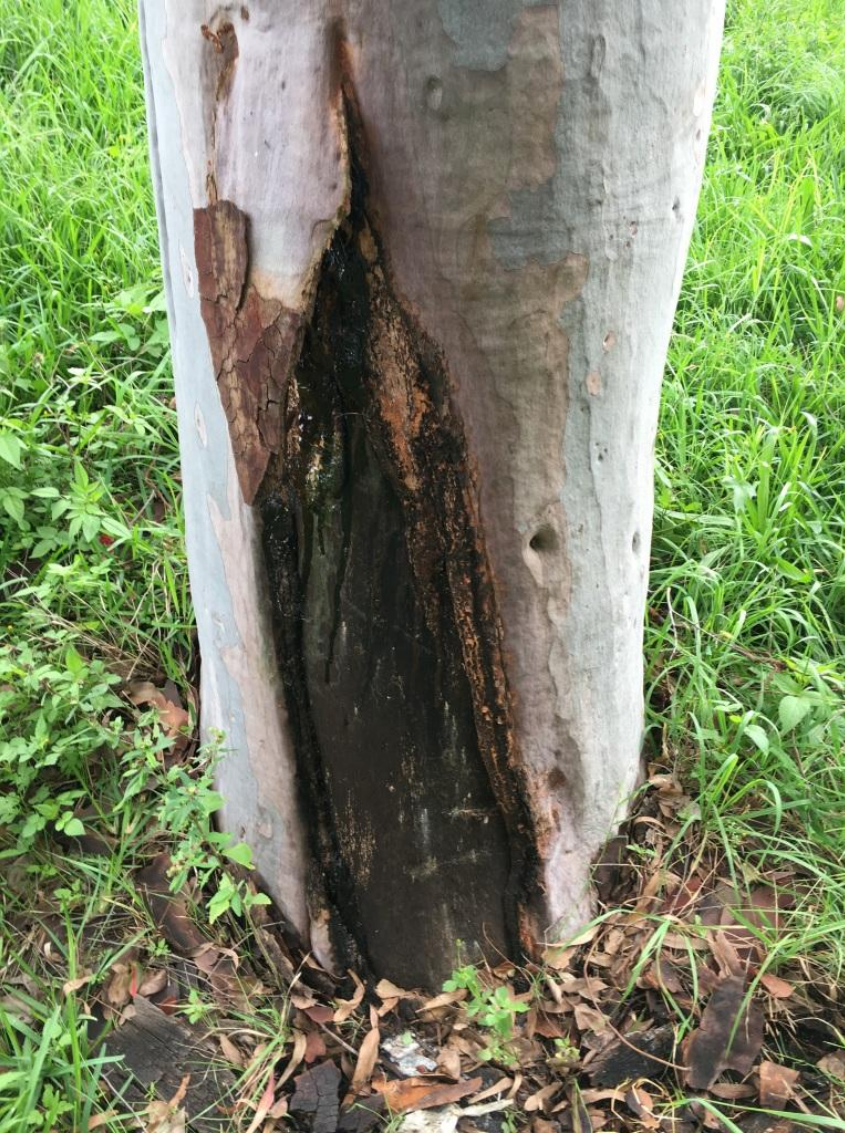
Photo 5 – Wound at base of Tree 5.

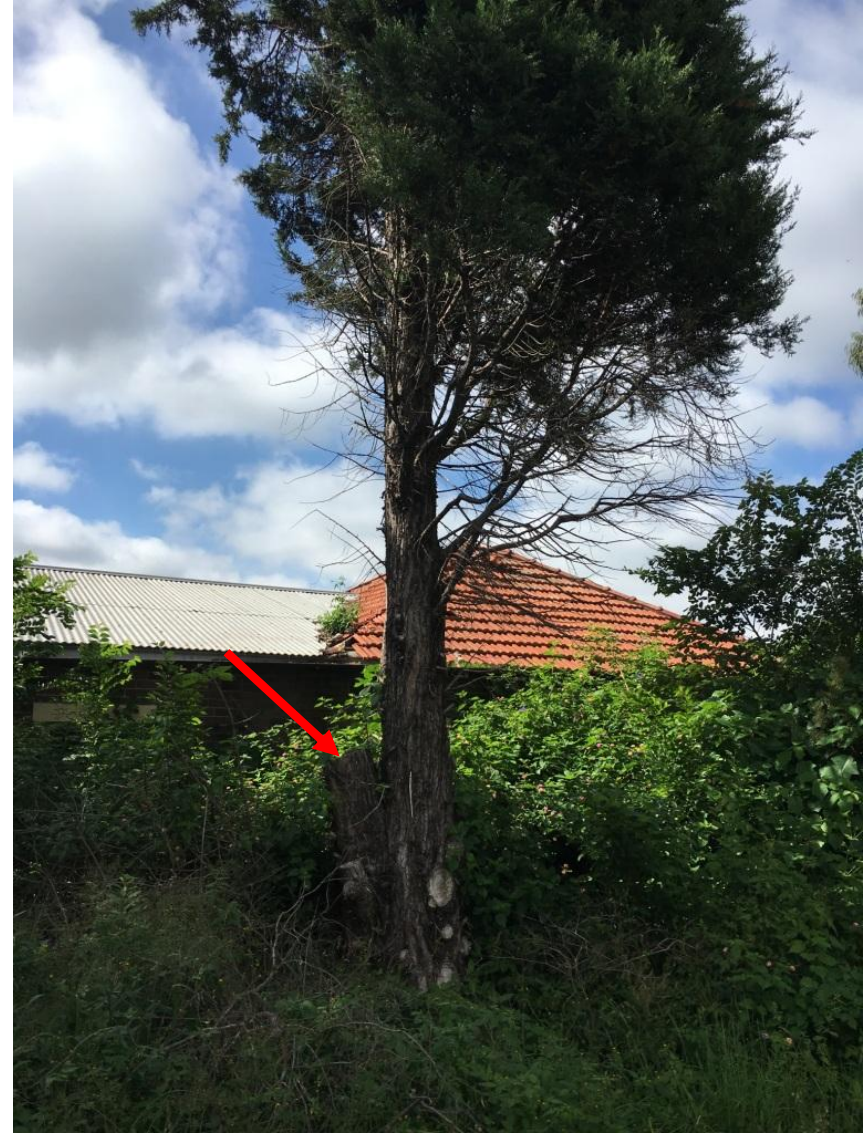
Tree 3 *Cupressus* sp. is a poor specimen that has previously lost 50% of the canopy when the co-dominant stem was removed (reasons unknown). The proposed perimeter fence is located within the SRZ of this specimen. The tree is of a condition not to warrant design changes.

Photo 6 – Tree 3; co-dominant stem that has been removed noted with red arrow.

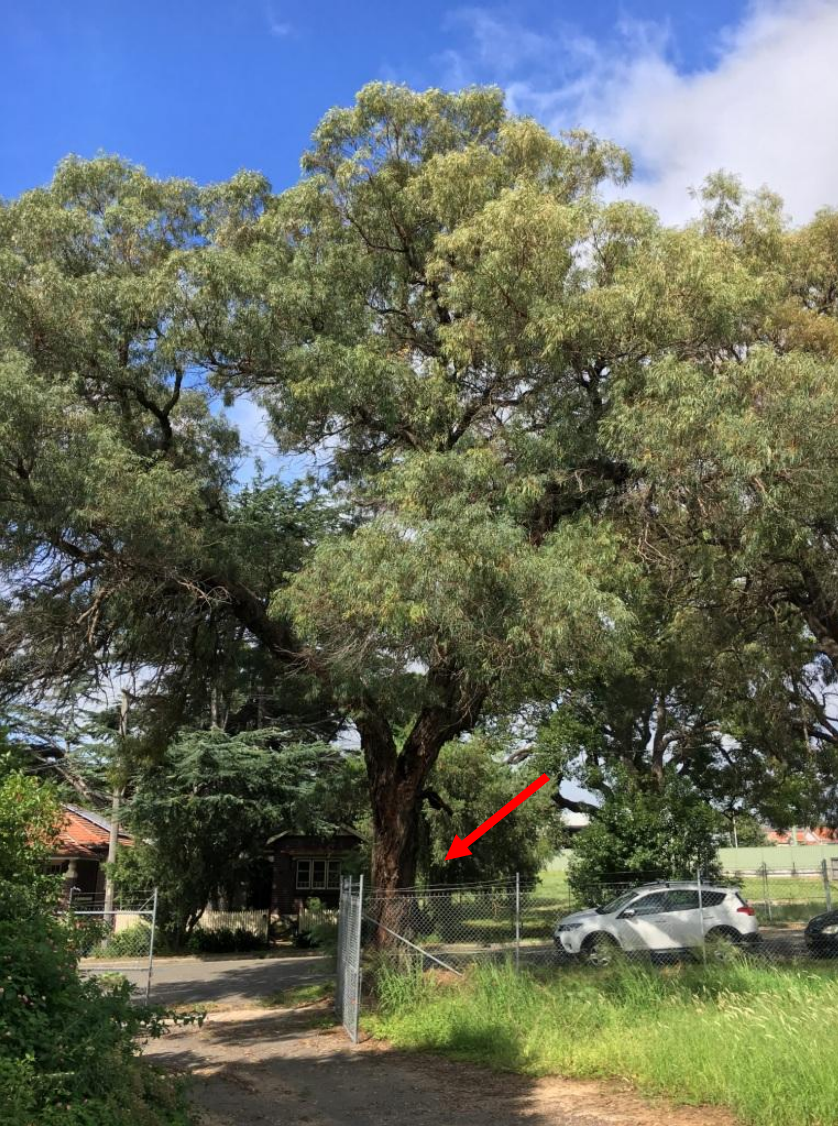
This street tree is also proposed to have site access/driveway within the TPZ. The notional encroachment has been calculated as 6.1%, this is considered minor encroachment under the Australian Standard 4970-2009 Protection of trees on development sites (“AS4970”). Again the encroachment will not require a reduction in ground level but minor increase in ground level.

A new perimeter fence is also proposed, this fence location is just on the outer extent of the SRZ and well within the TPZ. Retention of the existing fence, replacement of just the wire itself/use of existing poles/piers should be carried out to reduce impact on this tree. No excavation can be supported for fence installation. Branches are clear of the proposed fence height.

Photo 7 – Street trees; Tree 2 – current gate access.

Pruning is required allow vehicular access without risk of tree damage as branches are low over the proposed driveway area.

- Stem protection is required given works are required with the TPZ, this shall be padding placed against the stem and battens strapped together over this padding (not fixed in any way into the tree stem). A minimum height of 2m is recommended.

- Retention of the existing kerb is required due to the location to the tree stem (outside of driveway zone).
- Refer to Sections 4.2 – 5.3 for additional recommendations that may require adoption during works.

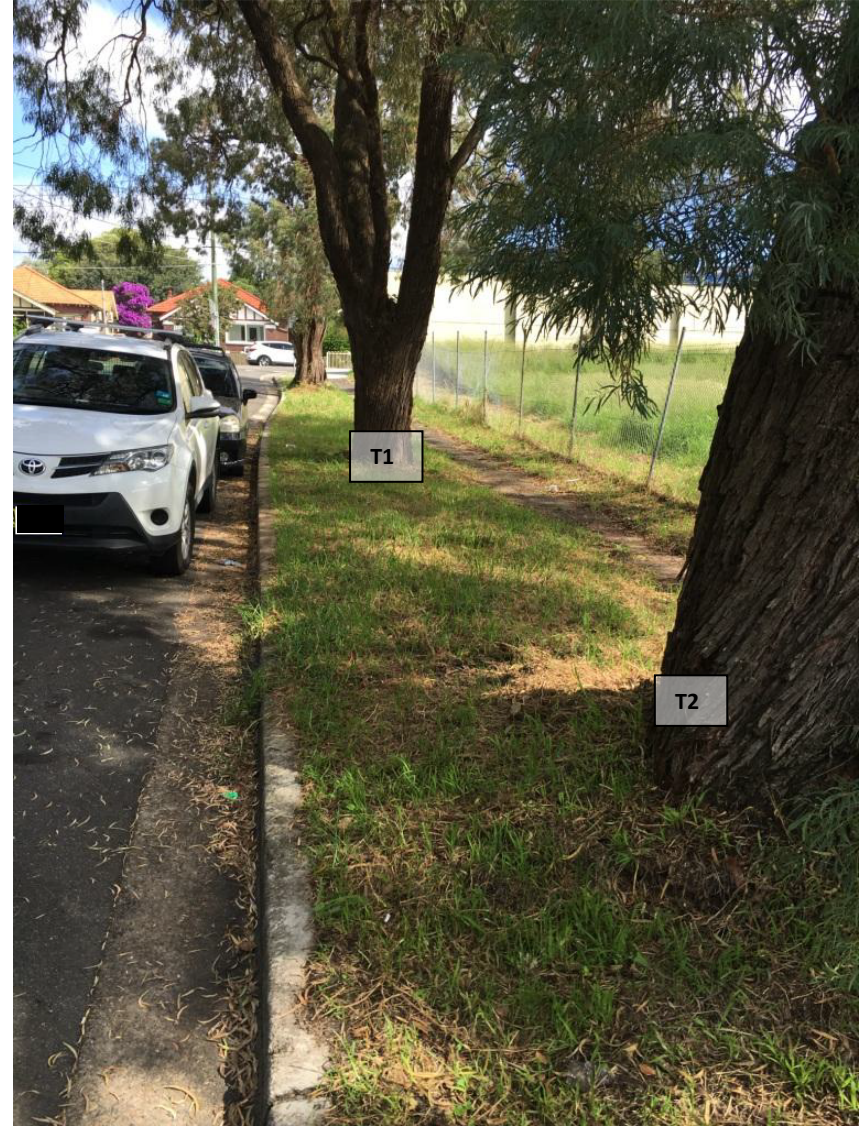
Under the current proposal site access will be within the TPZ of this street tree, a driveway is proposed and a new layback in the position of the existing gutter. The encroachment into the TPZ has been calculated as 10%. This is just on the threshold figure between minor and major encroachment under the Australian Standard 4970-2009 Protection of trees on development sites (“AS4970”). The encroachment will not require a reduction in ground level but a minor increase in ground level (as discussed on site). This should be acceptable and not detrimentally affect tree.

Photo 8 –The area between these two street trees is proposed to provide access into site.

Pruning will be also required to allow vehicular access without risk of tree damage or the tearing of limbs.

- Any ground-level change within 9 m of the tree is to be directly supervised by an arboriculturist with a minimum AQF5 in arboriculture or Council.
- Crown-lift pruning to Australian Standard 4373-2007 *Pruning of Amenity Trees* will be required by a minimally qualified AQF Level 3 Arborist prior to works commencing. Given the pruning may be in excess of 10% of the total live canopy, this pruning shall be as advised by the project arboriculturist or Council.

- Stem protection is required given works are required with the TPZ, this shall be padding placed against the stem and battens strapped together over this padding (not fixed in any way into the tree stem). A minimum height of 2m is recommended.

- Retention of the existing kerb is required due to the location to the tree stem (outside of driveway zone).
- Refer to Sections 4.2 – 5.3 for additional recommendations that may require adoption during works.
