# Arboricultural Impact Assessment

WESTCONNEX NEW M5  
ITS COMMUNICATION CONDUITS & FOOTPATH  
MARSH ST INTERCHANGE & WEST PRINCES HIGHWAY

*CDS reference: M5N-ES-RPT-ARN-0030*

# NOVEMBER 2019

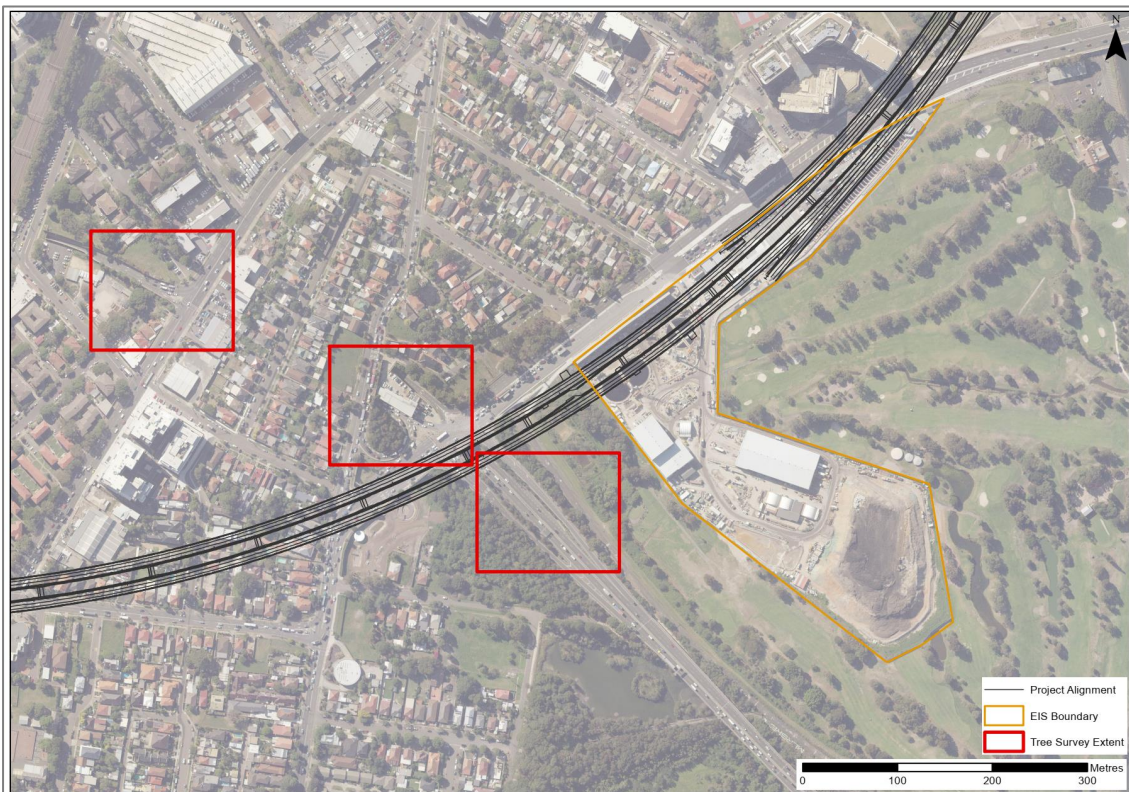
**Figure 1** - Location of proposed works for ITS installation at Marsh Street, Princes Highway as well as footpath, safety barrier and ITS conduit installation at Marsh St interchange.

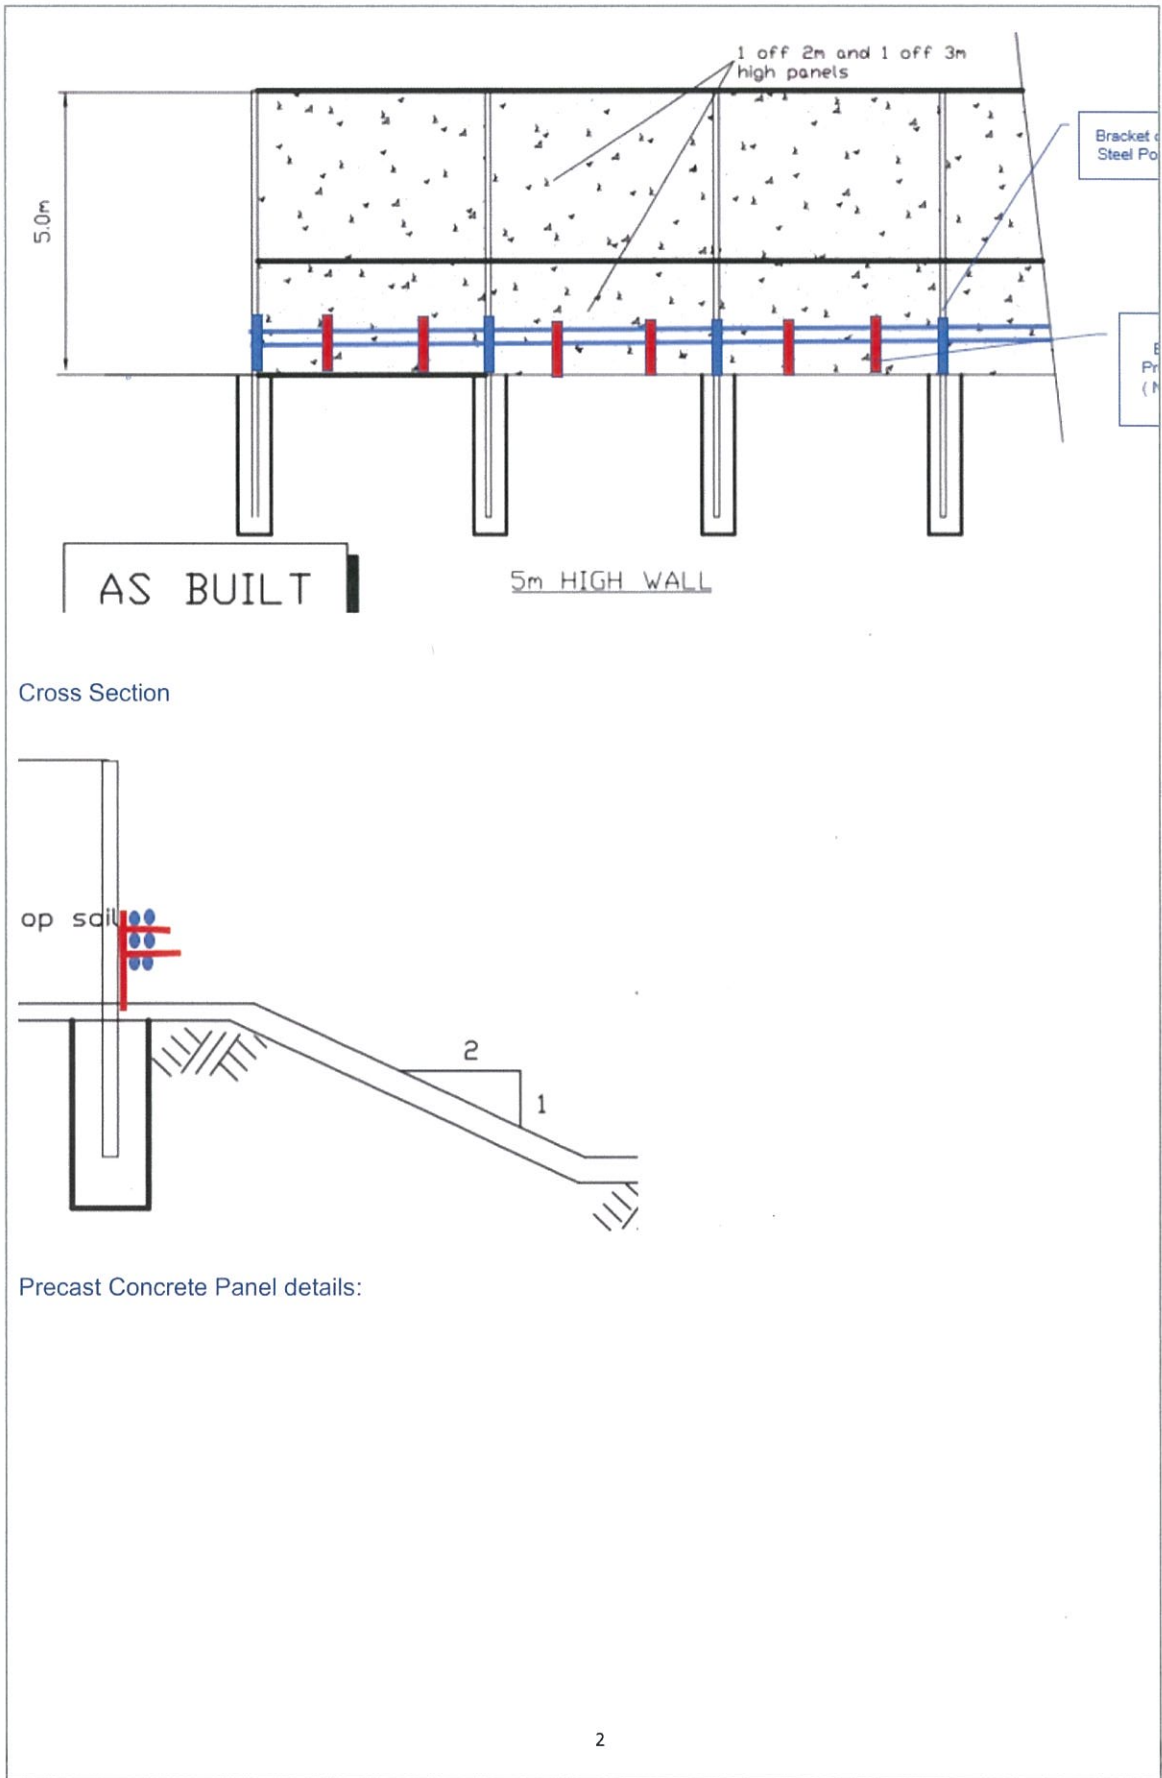
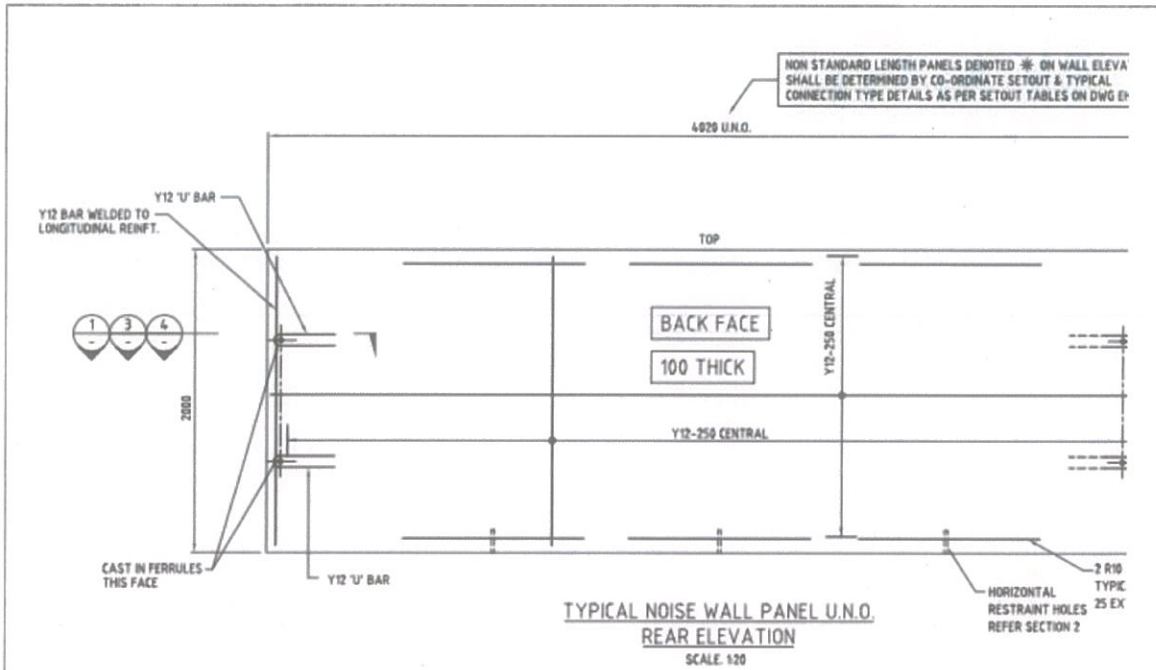
Elevation Noise wall

The Noise Wall Posts are spacing 4.0 m and has Precast concrete Panels in between. The HDG steel conducts need brackets every 1.50 m and those brackets cannot be attached to the Precast Concrete Panels due to those panels are not design for that.

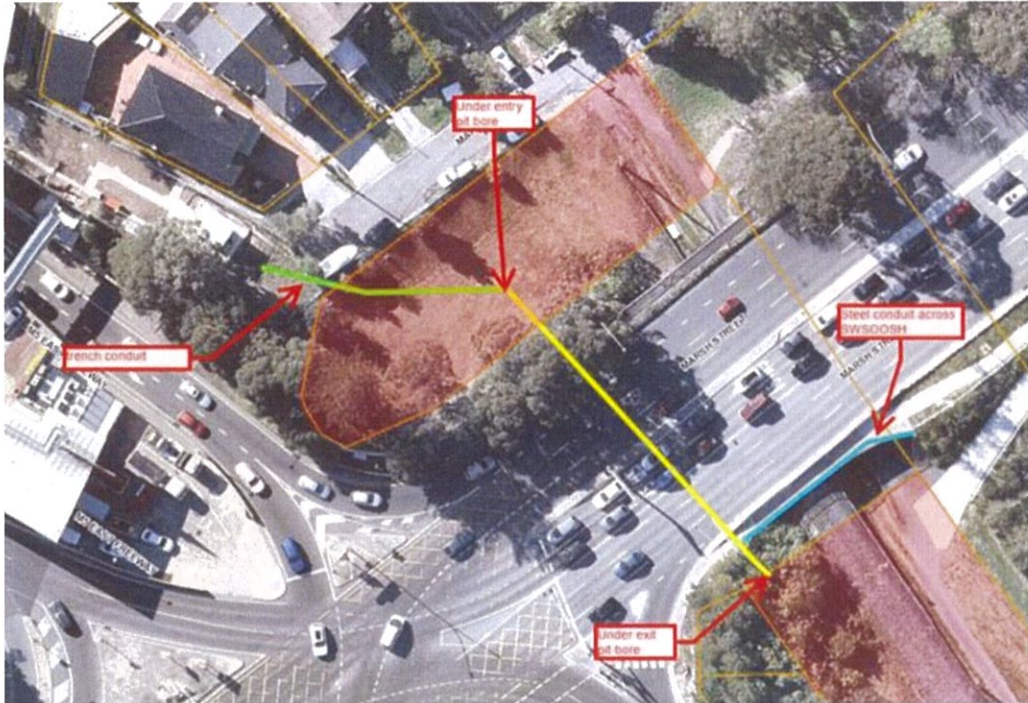
Original design was to have under bore as per below, SMC advised the adjacent land belongs to Sydney water and SMC/RMS will not be able to gain land acquisition for the required under bore and trenching works. SMC requested an alternate design to mount steel conduit on the bridge capping beam.

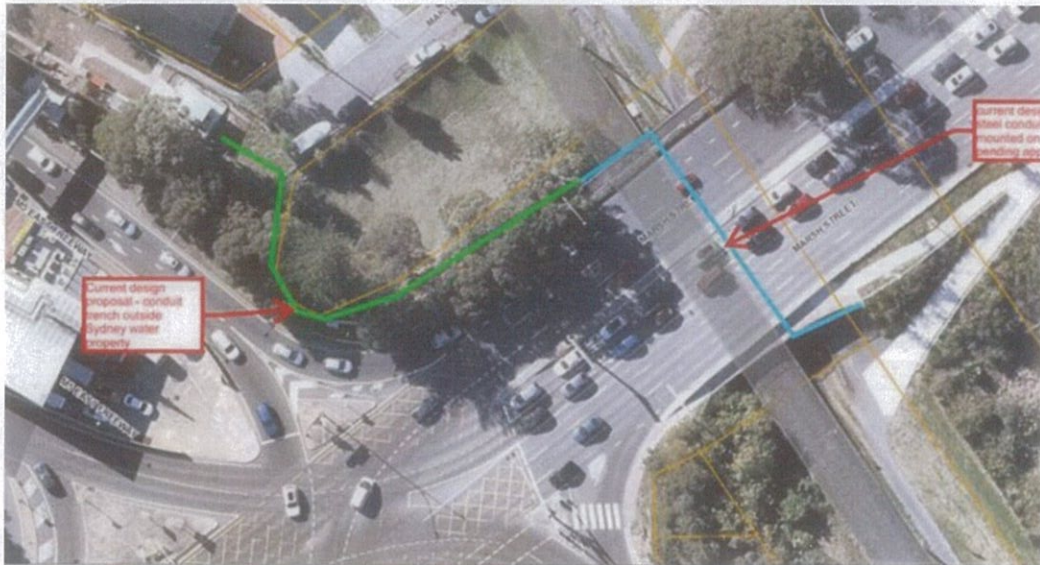
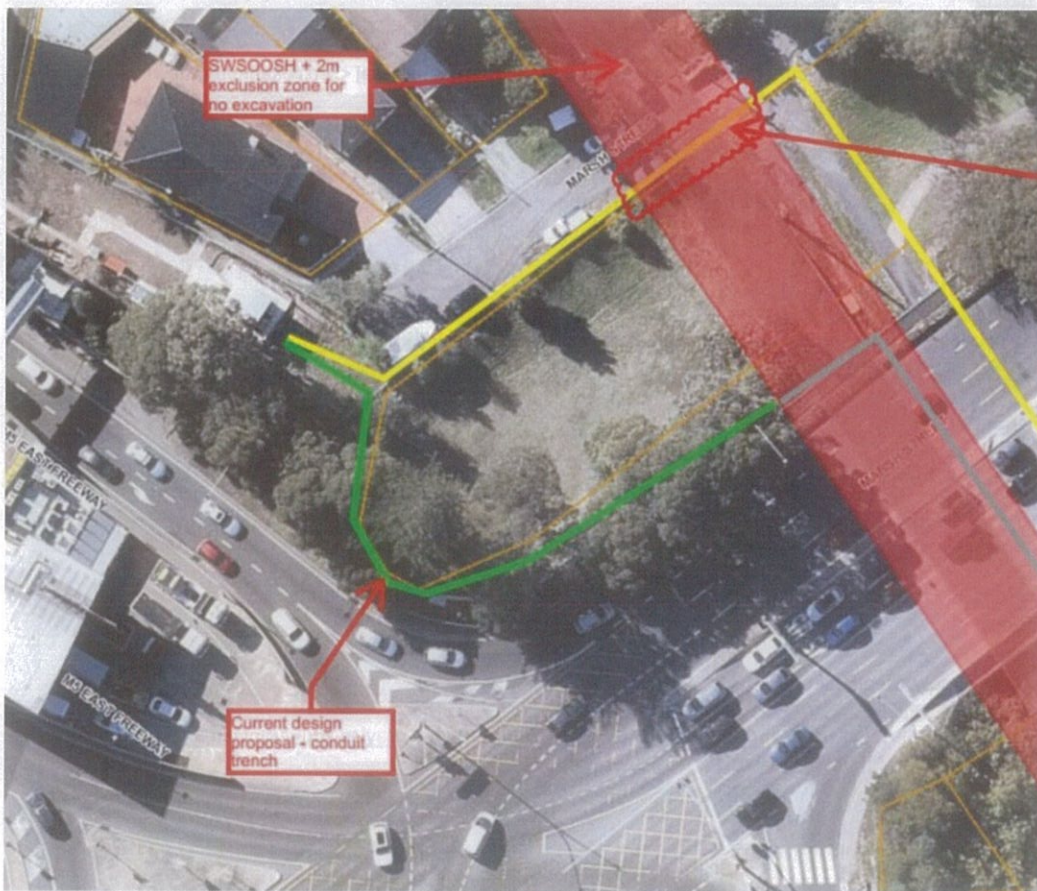
Alternate design below

1. there is a 2m buffer zone parallel to the SWSOOSH, which mean we will not be able to trench alongside or across the SWSOOSH. If we were to excavate a trench (in yellow) we would be inside the exclusion zone.
2. Mounting on the Wall – Note the conventional way of installing conduits is to trench them underground wherever possible unless any obstruction (ie SWSOOSH). Design assessment will be required to mount 6 steel conduits along with RMS approval. Support for steel conduit required every 1.5m which means support will be required on the noise wall concrete panels. This will impact the loading on the wall which it is not designed for along with future maintenance hence this option has not been investigated.

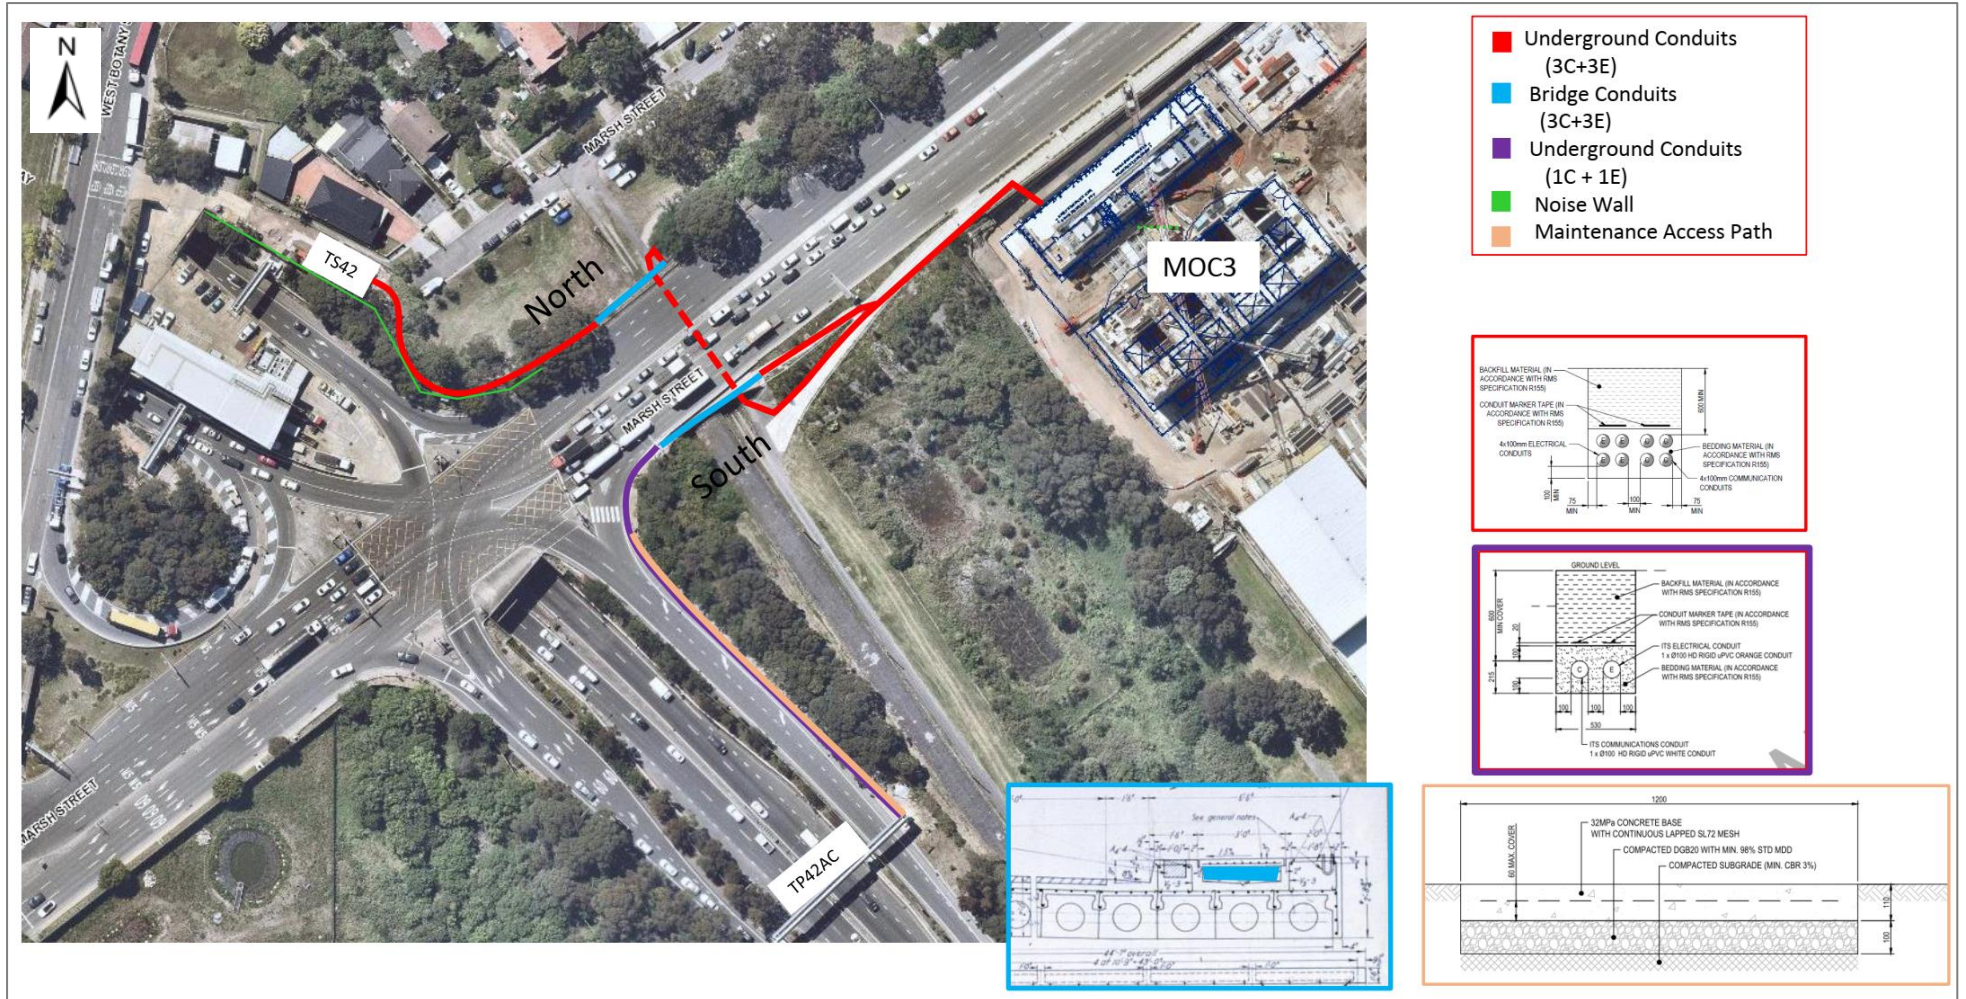
Figure 6 – Proposed conduit and access path locations. Existing noise wall location.

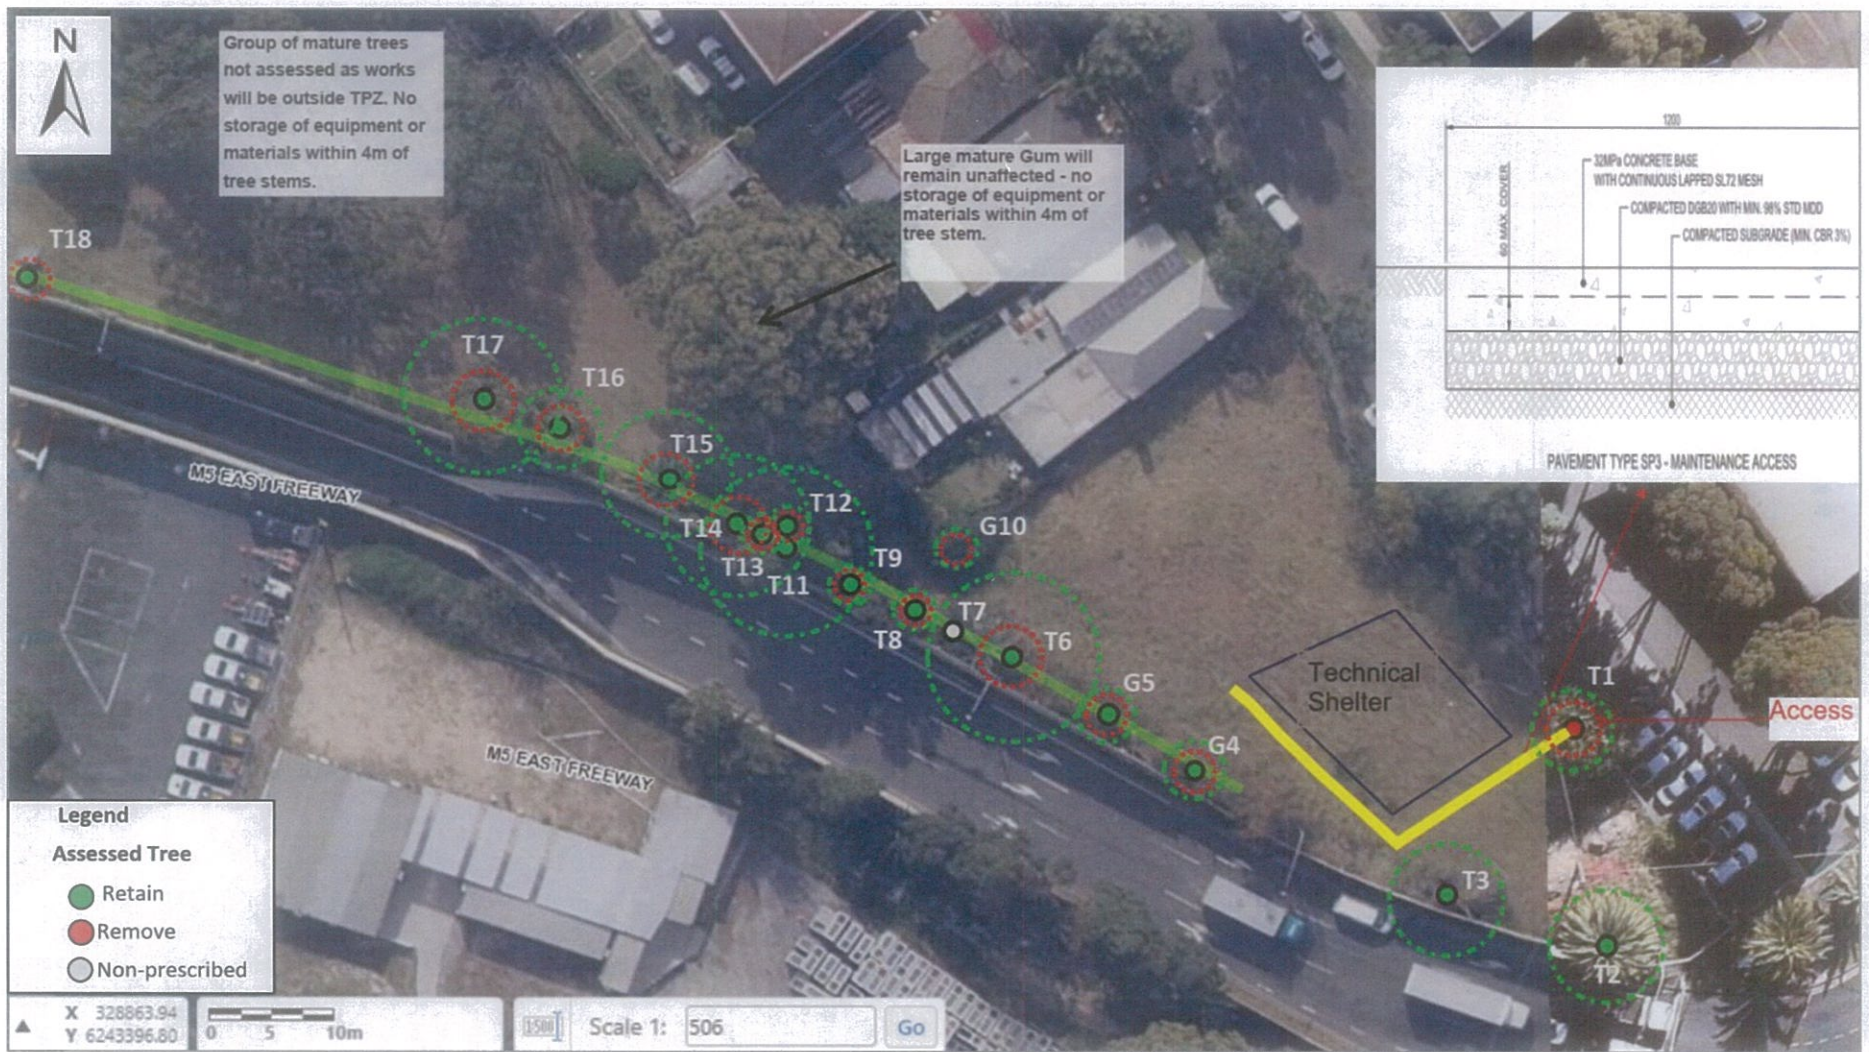
Figure 7 – Princes Highway interchange. Scaled aerial mapping marked up by [red dotted circles] Red dotted circles denote SRZ, TPZ noted with green hashed circle.

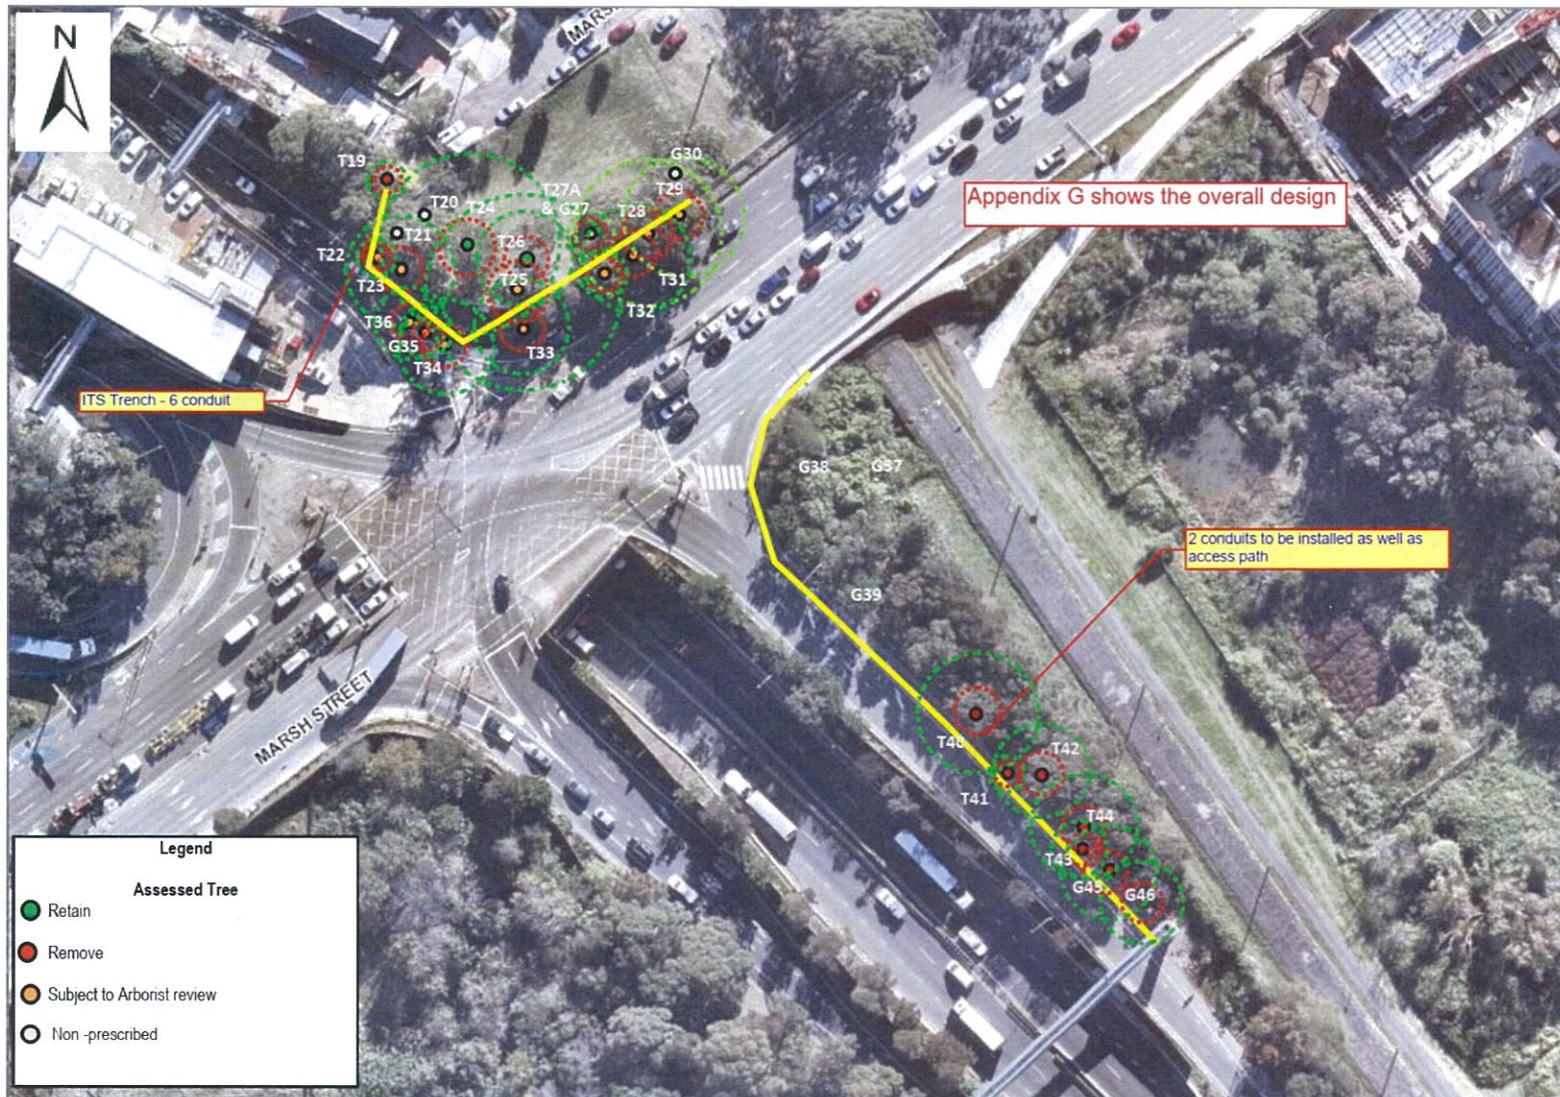
Figure 8 – Marsh St interchange. Scaled aerial mapping marked up by [redacted]. Red dotted circles denote SRZ, TPZ noted with green hashed circle.
