Pre-Construction Road Condition Report for WestConnex M5N

Project No: PSS17131

PSS17131-V2
June 2017

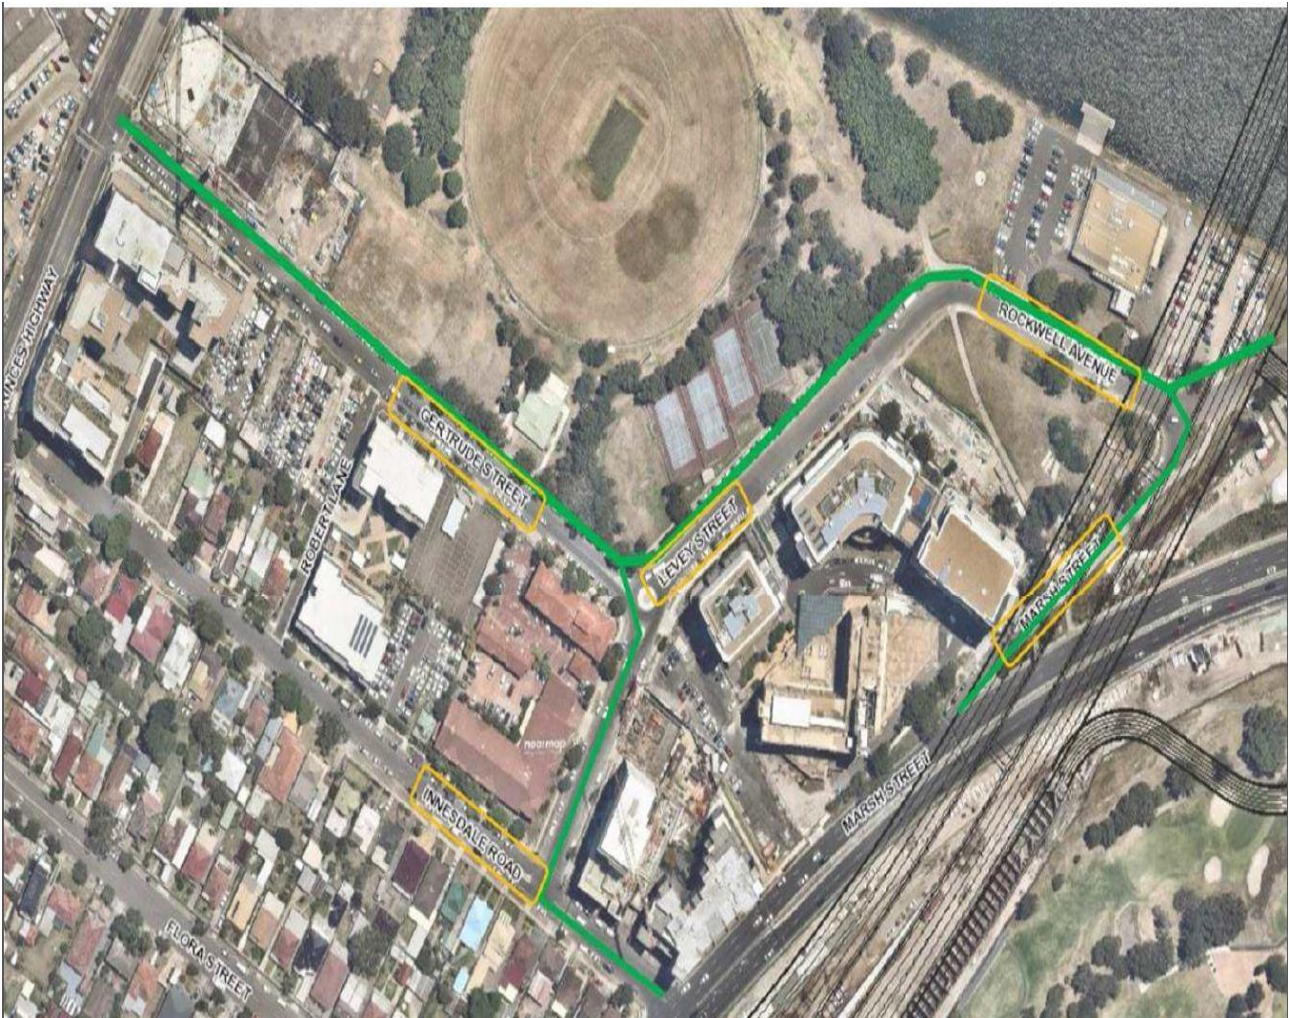
Figure 1.1: Surveyed road section Bayside Council (Gertrude Street, Levey Street, Rockwell Avenue, Marsh Street, Innersdale Road)

Pavement surface condition survey of the selected road sections of Bayside Council's network was undertaken by ARRB in May 2017 to collect surface condition distresses including rut depth, roughness, texture depth and cracking. The surveyed sections have been presented in Figure 1.1 and Figure 1.2.
