## **30, 34-40 and 82 Campbell Street St Peters**

Catalogue of Historic Building Fabric

Prepared for CPB Dragados Samsung Joint Venture

November 2016

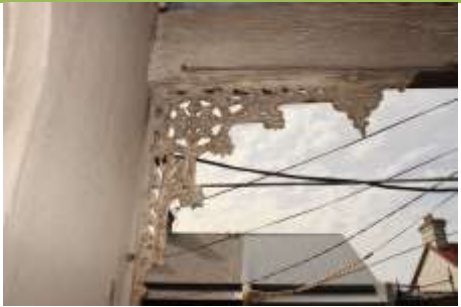
2	Verandah - wrought iron brackets	3		Lead (pb) paint

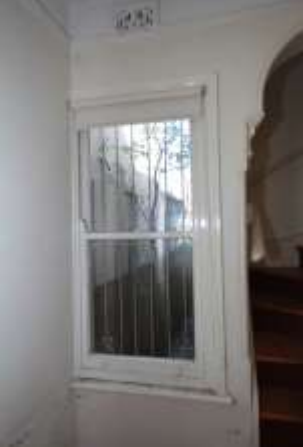
10	Window joinery – Large timber double-hung sash	6		Windows on building exterior contain lead (Pb) paint

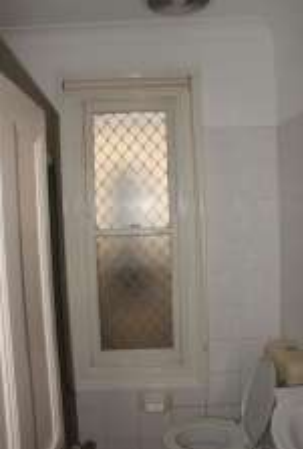
11	Window joinery – Small timber double-hung sash	2		Windows on building exterior contain lead (Pb) paint

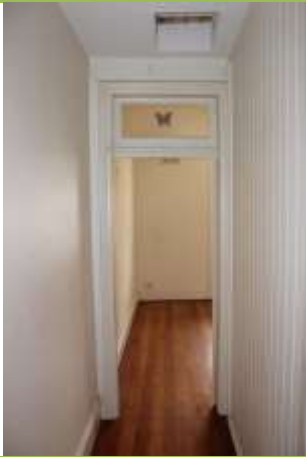
15	Window hardware – finger hooks	5			
16	Door joinery – timber frame	10	Entry and hallway frames are modified.

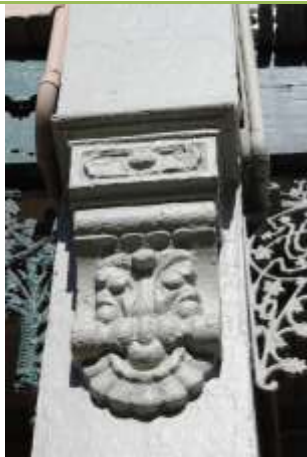
3	Verandah - wrought iron lacework	0			
4	Verandah – wrought iron fence	0			
5	Tessellated tiles	0			
6	Corbelled mouldings  Note: as the terraces share walls, they also share the corbelled mouldings. In total, there are 13 corbelled mouldings across the entire terrace group.	3		Lead (Pb) paint to western corbel

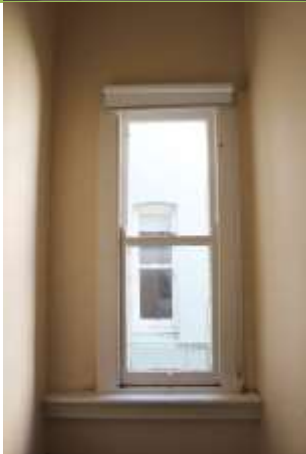
11	Window joinery – Small timber double-hung sash	2	Window in bathroom modified

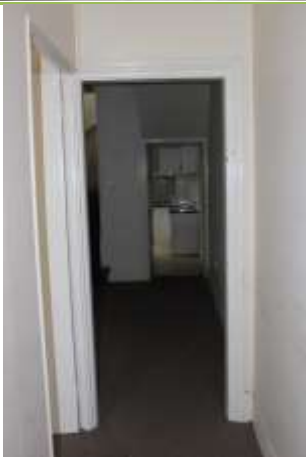
16	Door joinery – timber frame	4	Entry and hallway frames are modified.

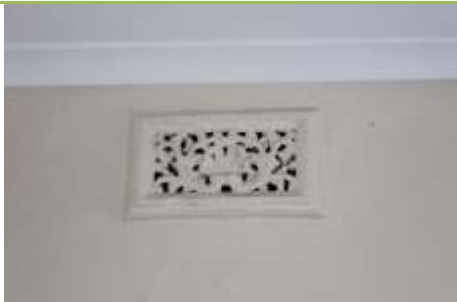
28	Wall – picture rail	0			
29	Chimney surrounds	0			
30	Tessellated tiles	0			
31	Vents – ceiling	0			
32	Vents – floor	0			
33	Vents – wall	1		Lead (Pb) paint

- Any salvage material found to contain hazardous material, i.e. lead paint, should be managed in accordance with current hazardous materials legislation.

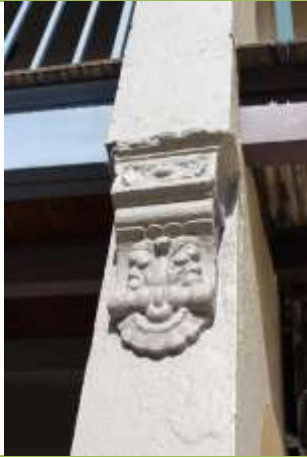
Ref. #	Feature	Qty	Notes	Hazardous Materials Present	Thumbnail
5	Tessellated tiles	0			
6	Corbelled mouldings  Note: as the terraces share walls, they also share the corbelled mouldings. In total, there are 13 corbelled mouldings across the entire terrace group.	2		Lead (Pb) paint on eastern corbel

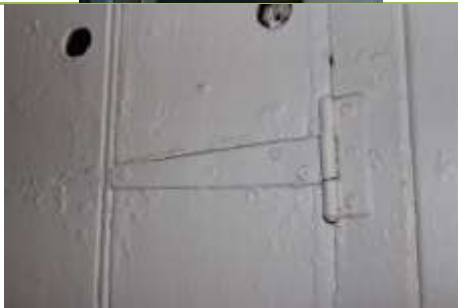
20	Door joinery - hardware	1	Pantry hardware

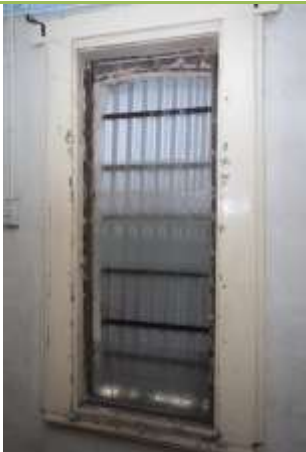
Ref. #	Feature	Qty	Notes	Hazardous Materials Present	Thumbnail
11	Window joinery – 1920s style timber window	1			 
12	Window joinery – Large timber double-hung sash	2	Both windows incomplete – missing original windows and hardware		 
13	Window hardware - locks	0			
14	Window hardware – sash & pulley	0			
15	Window hardware – finger hooks	0			
16	Window glazing	2

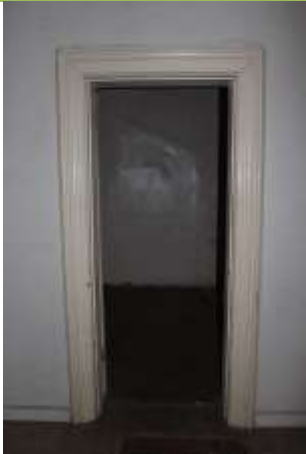
Ref. #	Feature	Qty	Notes	Hazardous Materials Present	Thumbnail
17	Door joinery – timber frame	4	One original height door between the two front rooms
